Black Mountain Wilderness Proposal

**ARIZONA
WILDERNESS
COALITION**

October 2004

Route Analysis and Photo Documentation
For the
Black Mountain Unit

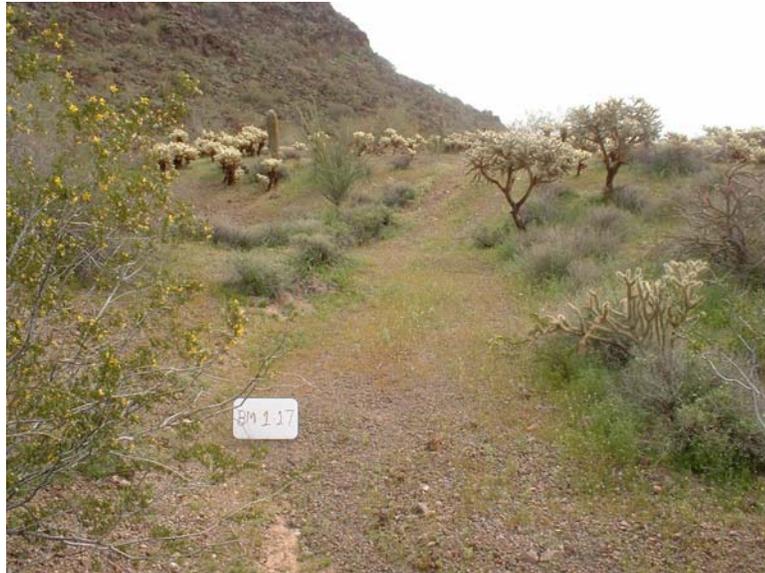
BM-1-17 Route 5 overgrown no use evident
Direction: E

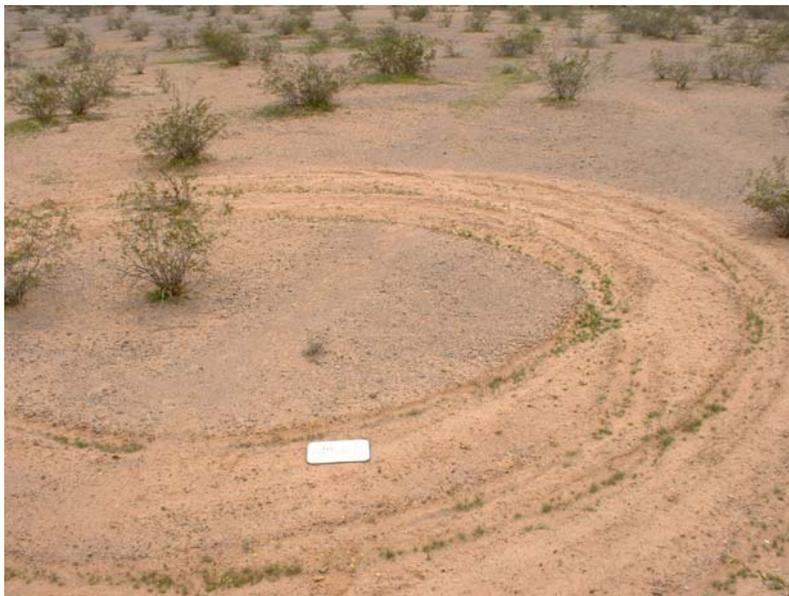
BM-2-18 ORV damage on route 14

The occurrence of torn-up vegetation and erosion leading to topsoil loss from Off Road Vehicle use is highly destructive to this fragile desert ecosystem. Such actions are not appropriate anywhere. Off Road Vehicle use in this area is the number one impact to resource values. The evidence is so clear that it would not take a study to determine that the problem is the proliferation of illegal wildcat routes used for the sole purpose of recreational Off Road Vehicles. These uses are incompatible with the preservation and protection of the values of the study unit and therefore do not pose a valid resource conflict other than that they are rapidly destroying the wilderness character of the Black Mountain unit.

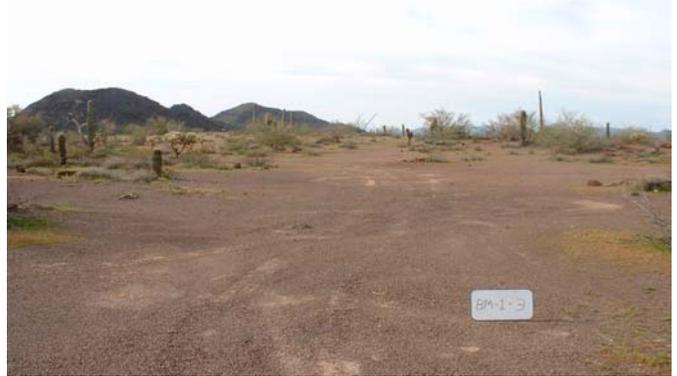
BM-1-3 ORV damage on desert pavement/cross-country travel off of route 1

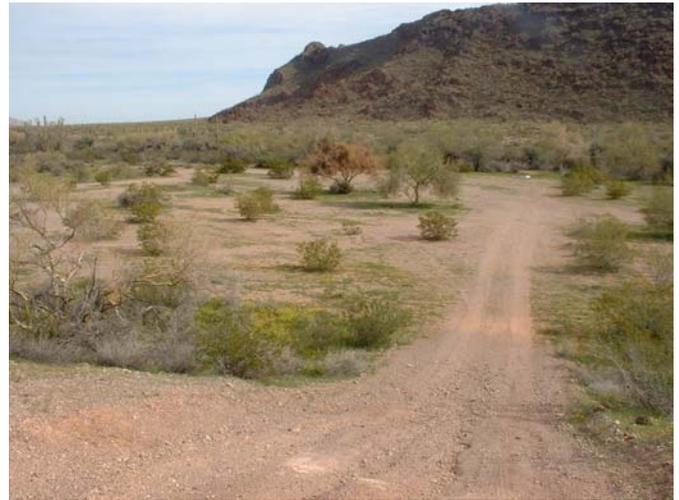
BM-1-9 ORV play area and camping
Direction: NW

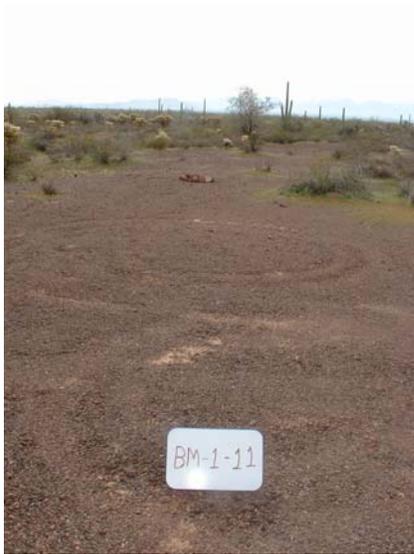
Other Impacts: some one time cross country travel ORV tracks and donuts as in photo BM-1-11

BM-1-11 ORV donuts on route 4,
Direction: SE

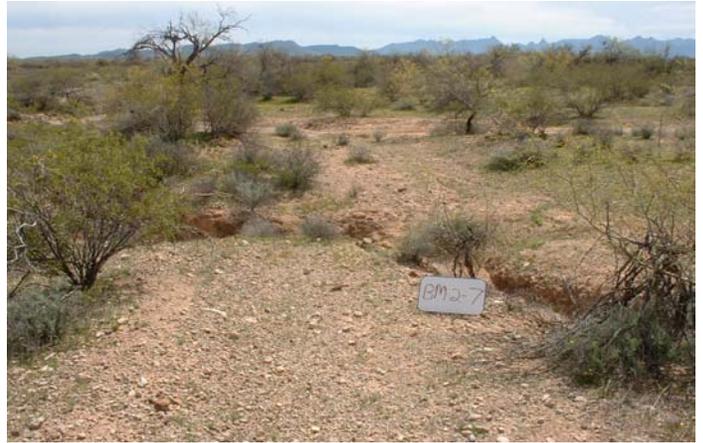
BM-2-7 Bad erosion on shortcut no use evident
Direction: SE

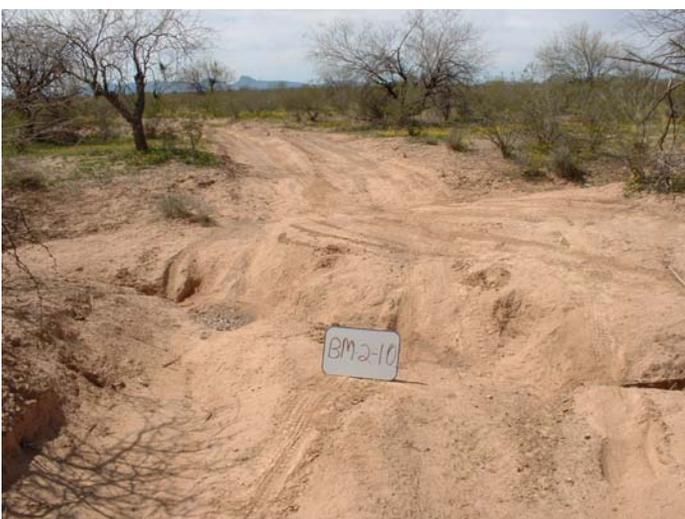
BM-2-10 Worst erosion on route 10
Direction: SW

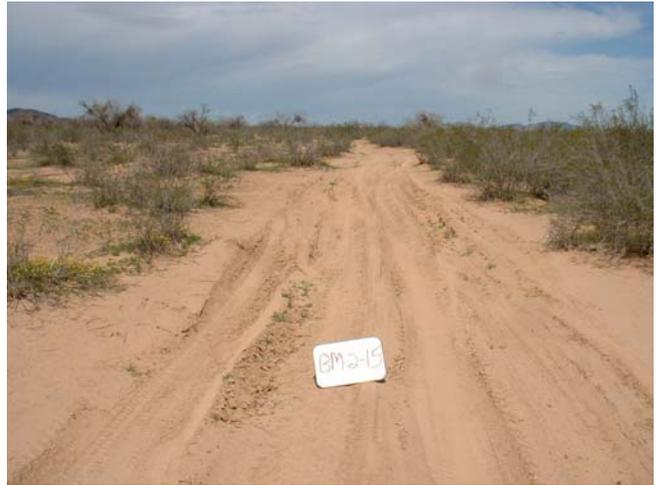
BM-2-15 Worst erosion, braided on route 12

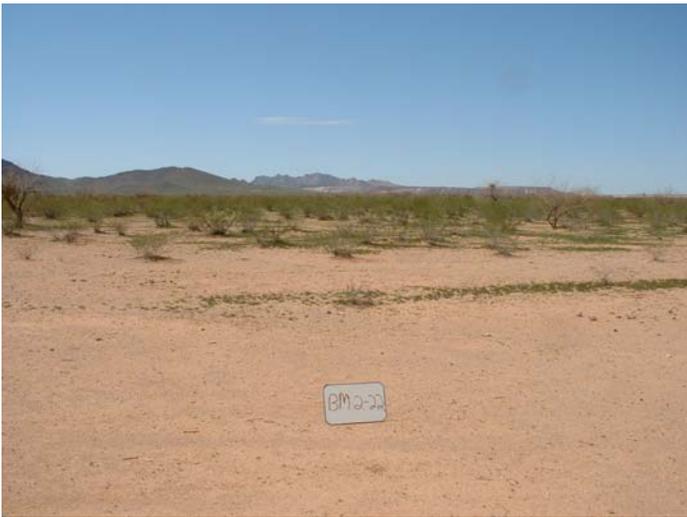
BM-2-22 Erosion impacts off of route 12 and naturalness inside unit. Direction: NW

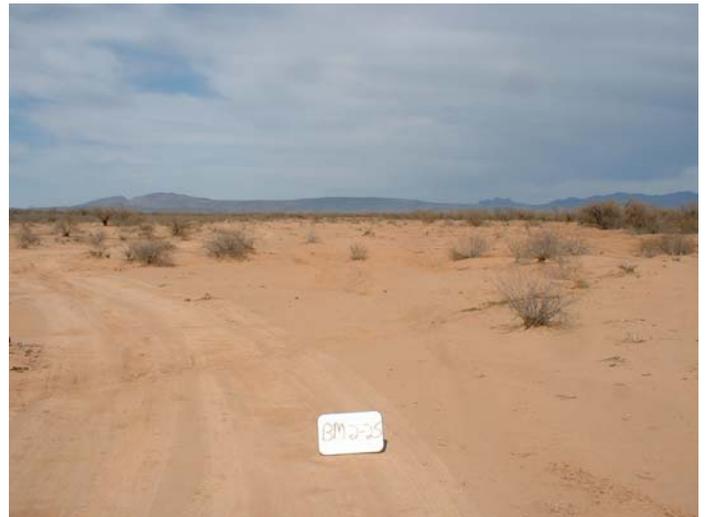
BM-2-25 Erosion impacts off of route 12 and naturalness inside unit. Direction: N

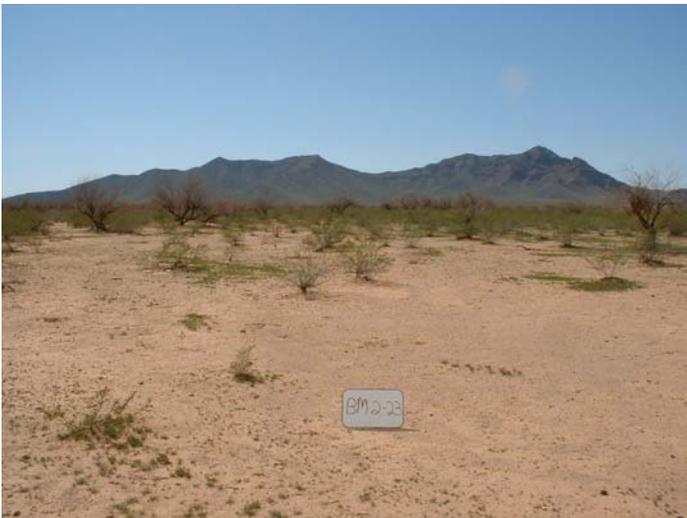
BM-2-23 Erosion impacts off of route 12 and naturalness inside unit. Direction: SW

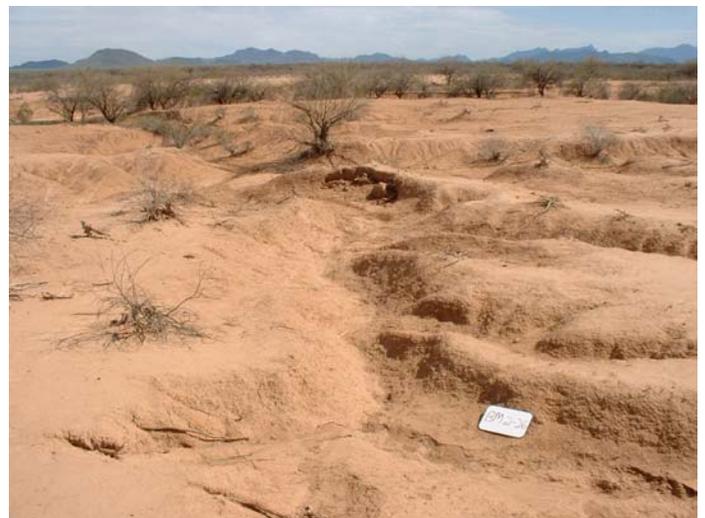
BM-2-26 Massive soil lose next to route 12 Direction: SE

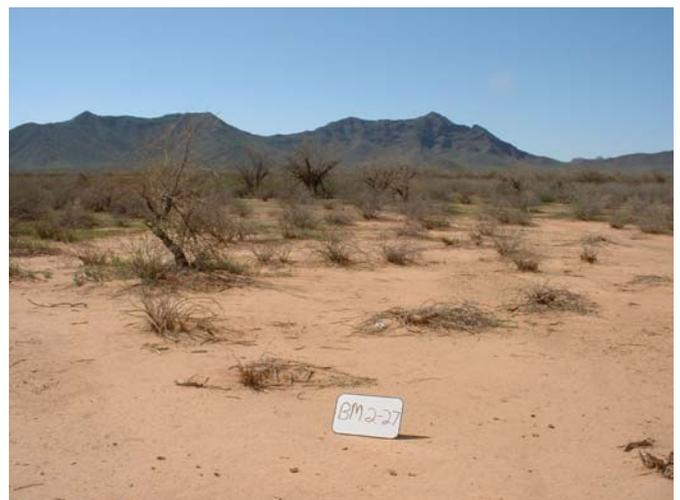
BM-2-27 Erosion impacts off of route 12 and naturalness inside unit. Direction: W

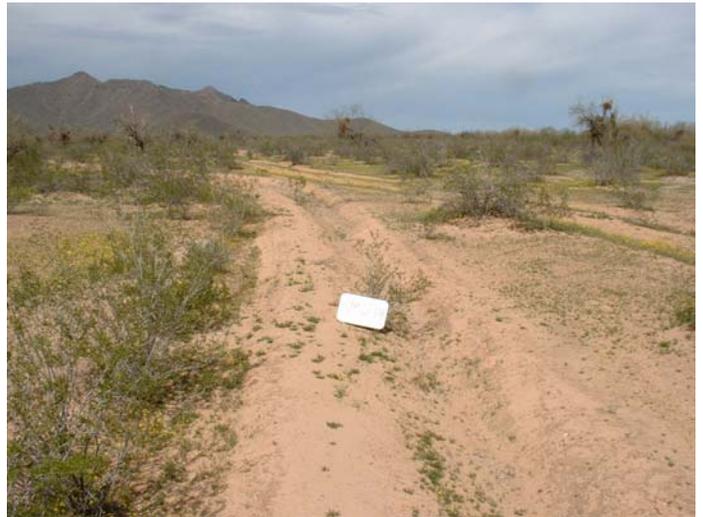
BM-2-14 Worst erosion no use evident end route 13

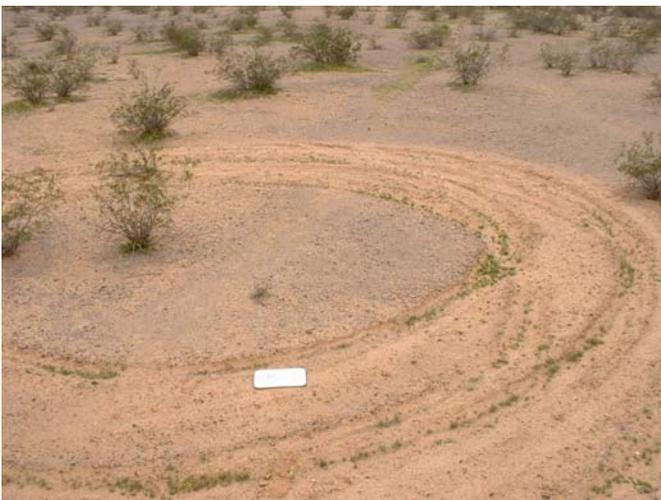
BM-2-18 ORV damage on route 14
Direction: N/A

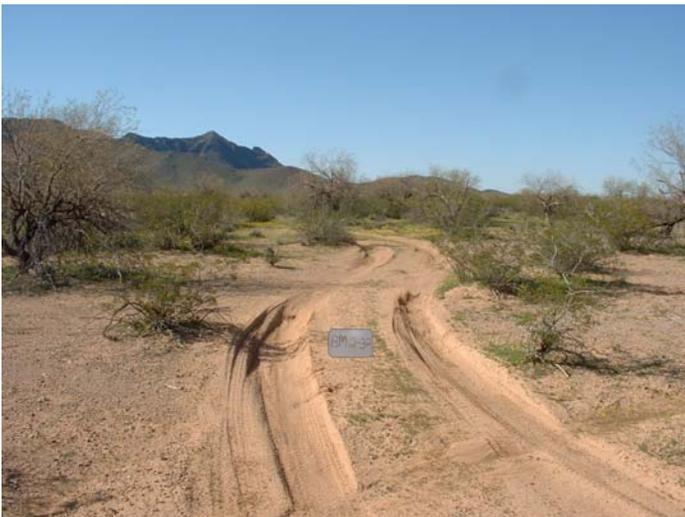
BM-2-32 Worst erosion on route 15
Direction: N

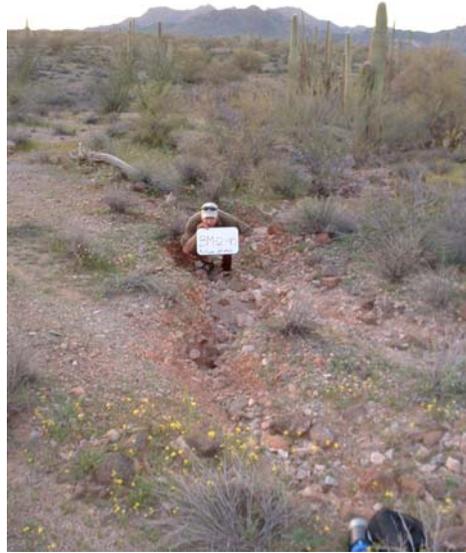
BM-2-40 Worst erosion on route 17
Direction: NW
