Proposed Lands With Wilderness Characteristics:
ARAVAIPA SOUTHEAST
Public Lands in Pinal and Graham Counties, Arizona

A proposal report to the Bureau of Land Management,
Safford Field Office, Arizona
February, 2018
Prepared by Samuel Wershow

Aravaipa Southeast Proposed LWC

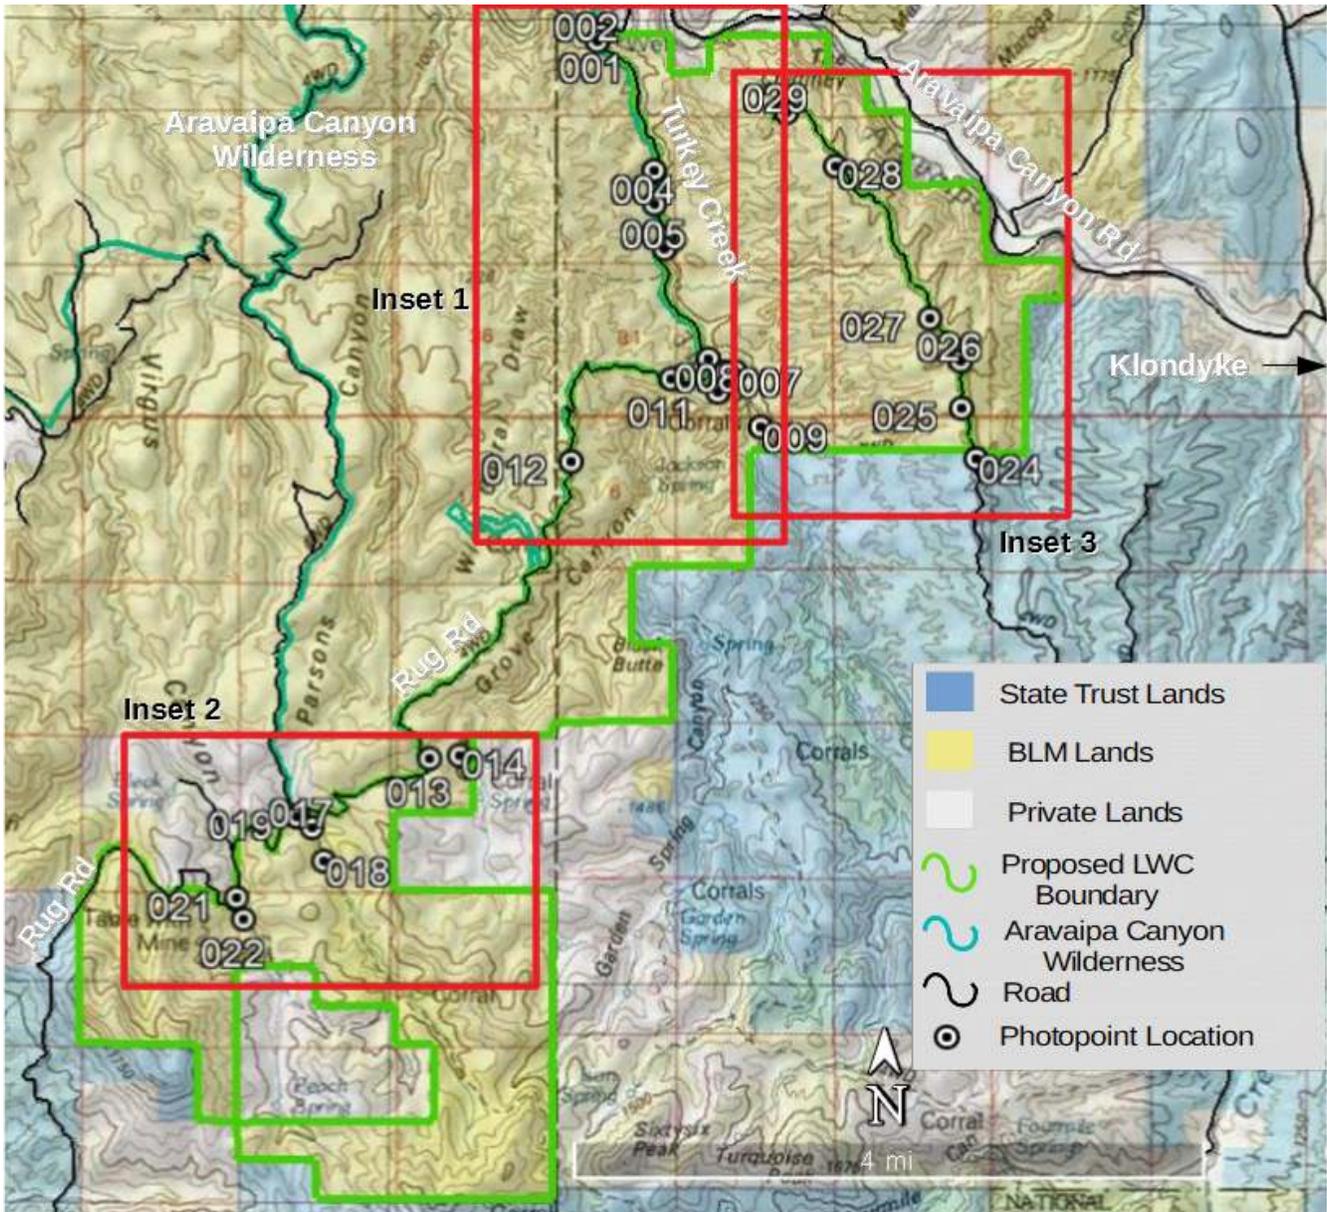
Aravaipa SE Reference Map – Showing location of inset maps and photopoints along the unit boundary. The western unit boundary is formed by Turkey Creek and then the Rug Road, a rough OHV trail separating the proposed LWC from the Aravaipa Canyon Wilderness. The remainder of the unit boundary is comprised of a patchwork of State and private land boundaries.

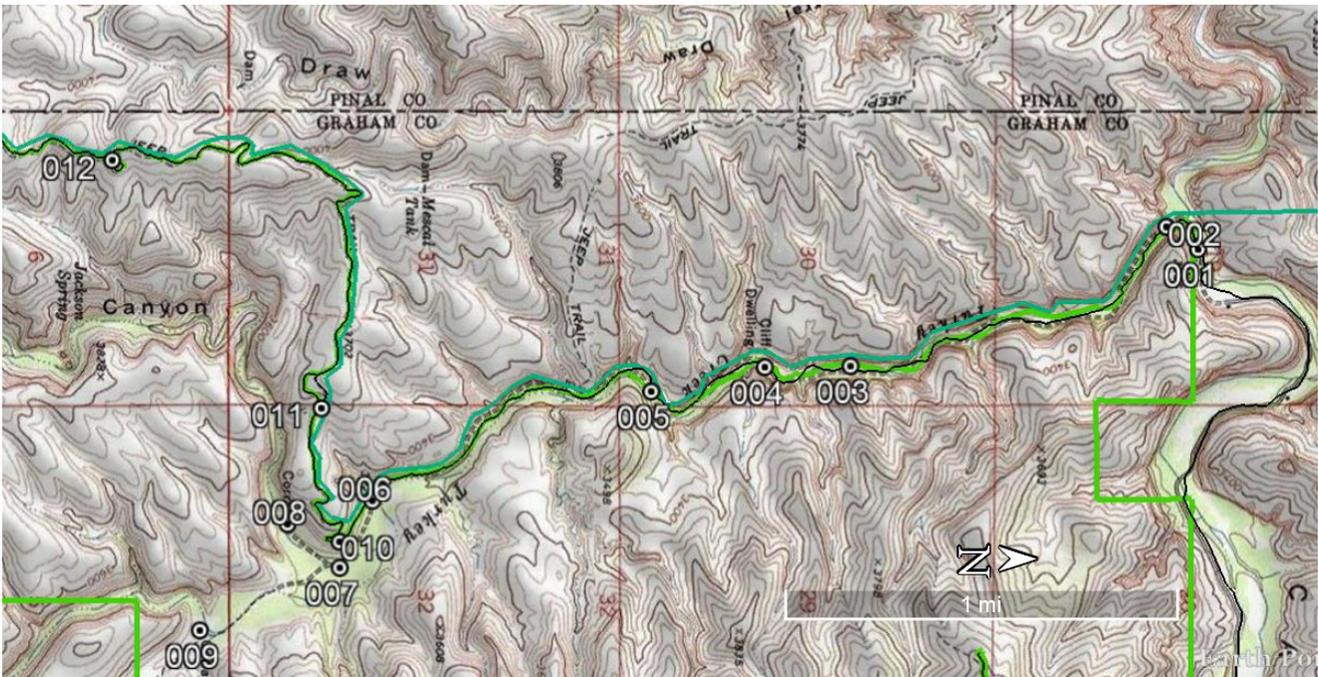
Inset Map 1 – Photopoints 001-012, along the western unit boundary. Photopoints 001-005 show features along Turkey Creek. 006-010 are impacts associated with a closed primitive route leading to several abandoned corrals. Beyond 010, the unit boundary becomes the Rug Road, a rough OHV trail.

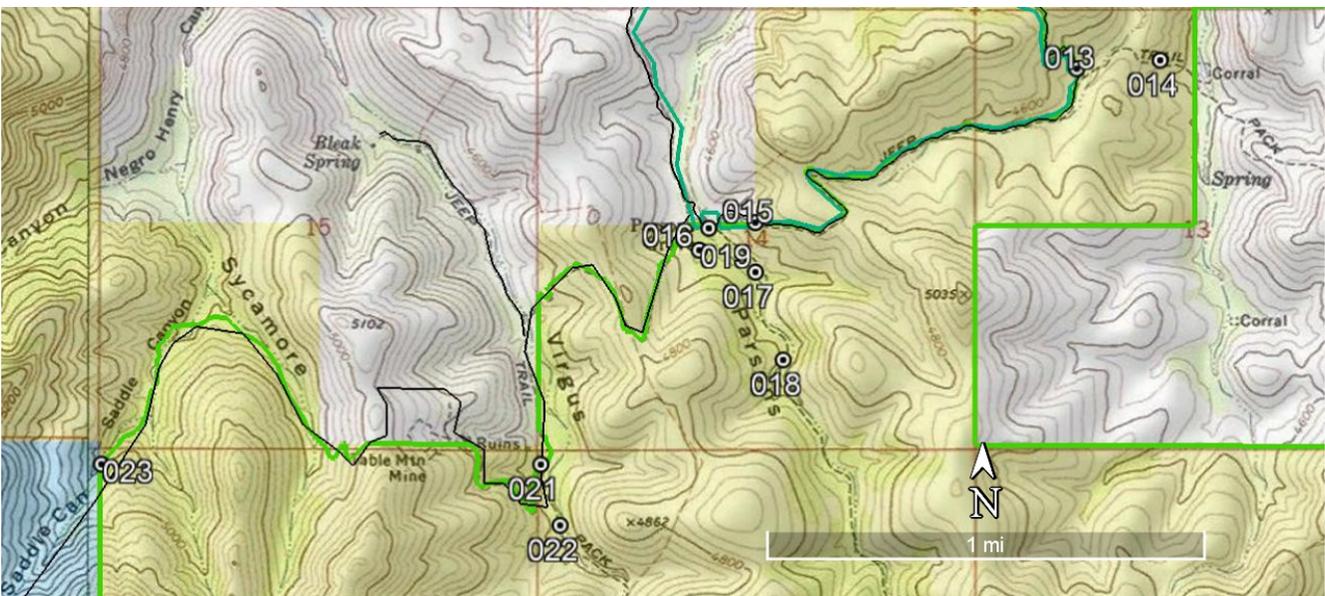
Inset Map 2– Photopoints 013-023, along the western unit boundary. 013-014 are an unmaintained stock route. 015-019 are features associated with Parson’s Grove, a historic development near a spring, including an old stock trail. 021-022 are another unmaintained stock route.

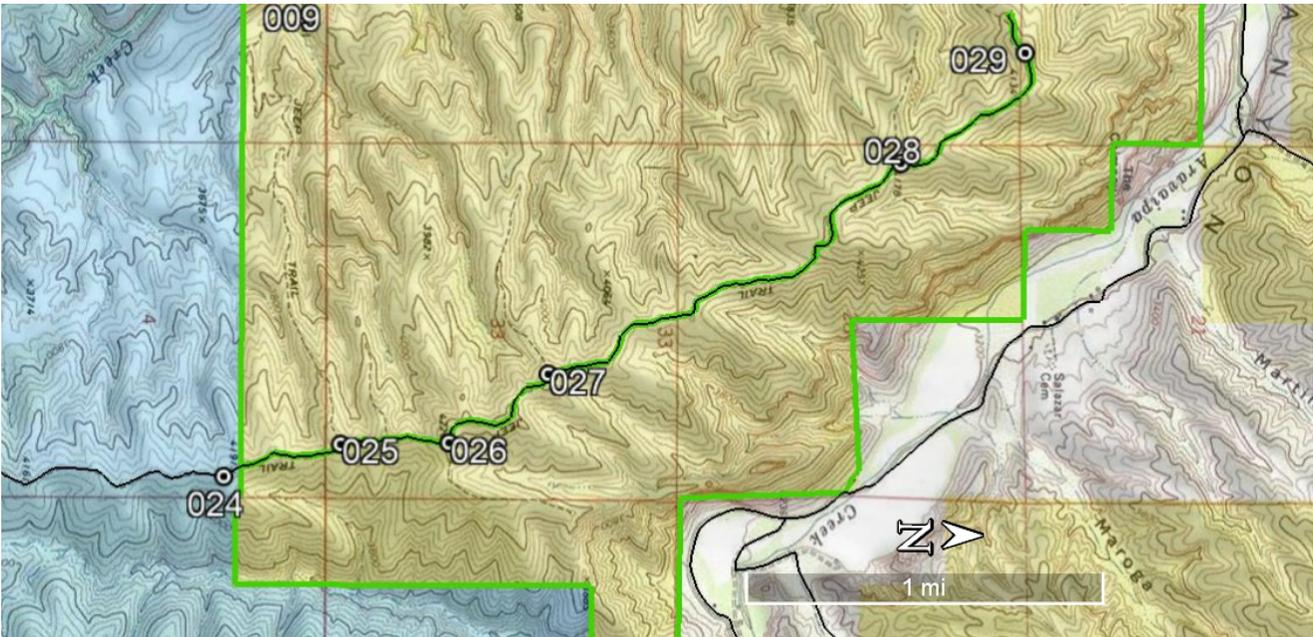
Inset Map 3 – Photopoints 024-029, a cherrystem heading north into the northeastern portion of the unit. The cherrystem has four primitive ways branching off of it (025-028), and ends at a primitive campsite/scenic overlook (029).

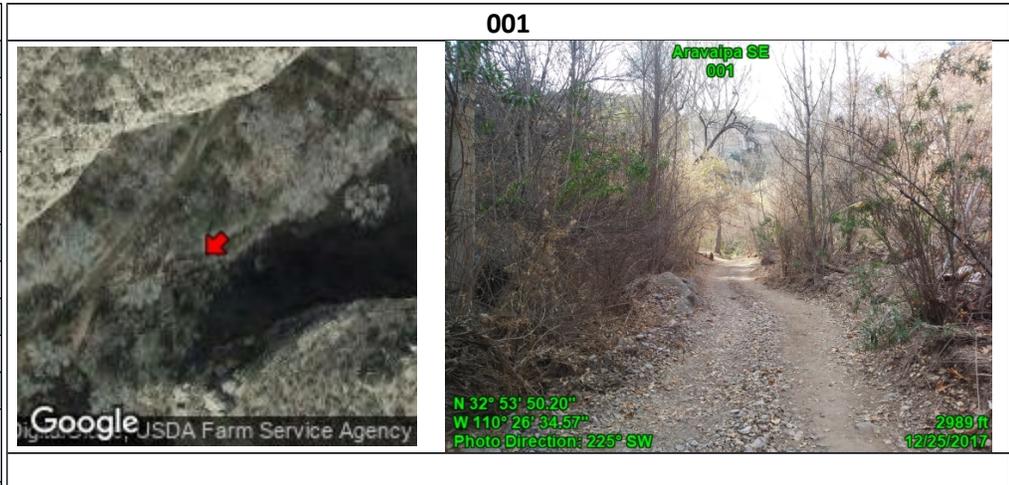
Attributes	
Unit name	Aravaipa SE
Point	001
Feature Class	Boundary Element
Feature	Typical Condition of Route
Feature notes	Used and maintained
Route: Determination	Road
Route: name	Aravaipa canyon rd
Route: Construction	Bladed
Route: Use	4-WD Trucks
Route: Maintenance	Very recent - past year
Route: Purpose	Multiple uses
Route: Improvements	None
Other notes	Unit Boundary

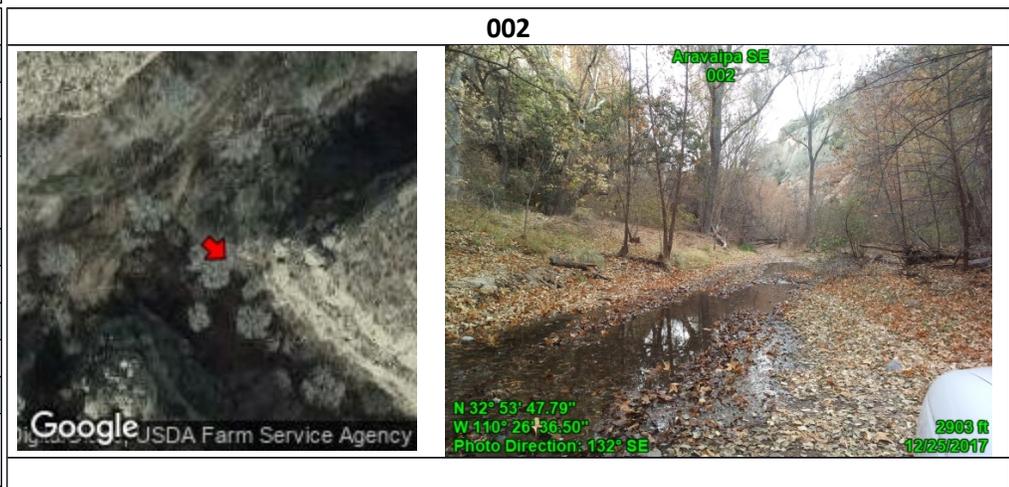
Attributes	
Unit name	Aravaipa SE
Point	002
Feature Class	Primitive Route
Feature	Typical Condition of Route
Feature notes	Boundary road?
Route: Determination	Road
Route: name	Turkey creek rd
Route: Construction	Bladed
Route: Use	4-WD Trucks
Route: Maintenance	Old evidence - 3-5 years ago
Route: Purpose	Multiple uses
Route: Improvements	None
Other notes	Unit Boundary

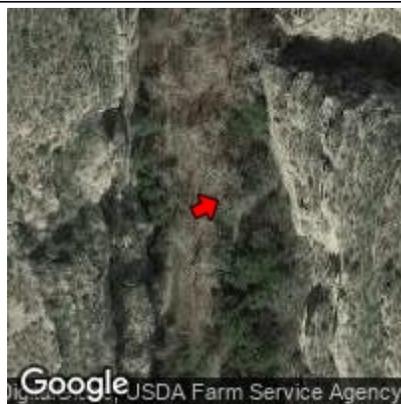
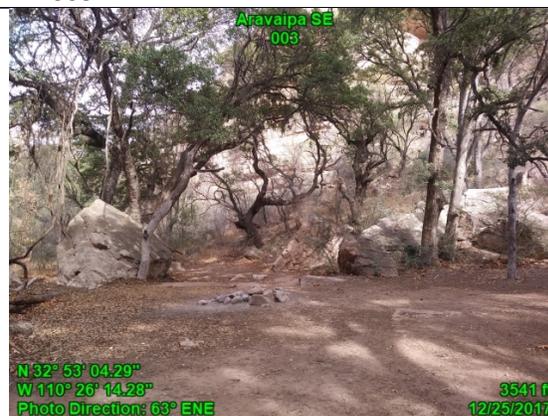
Unit name	Aravaipa SE
Point	003
Feature Class	Impact: Excluded
Feature	Campsite
Feature notes	Feature minimally affects naturalness
Route: Determination	N/A
Route: name	N/A
Route: Construction	N/A
Route: Use	N/A
Route: Maintenance	N/A
Route: Purpose	N/A
Route: Improvements	N/A
Other notes	None

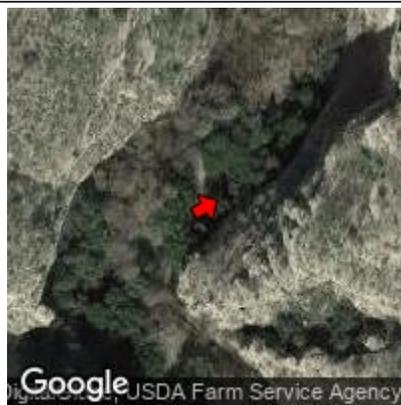
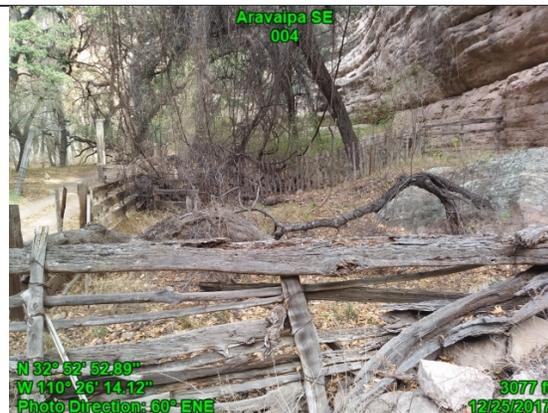
Unit name	Aravaipa SE
Point	004
Feature Class	Impact: Excluded
Feature	Corral
Feature notes	Feature minimally affects naturalness
Route: Determination	N/A
Route: name	N/A
Route: Construction	N/A
Route: Use	N/A
Route: Maintenance	N/A
Route: Purpose	N/A
Route: Improvements	N/A
Other notes	None

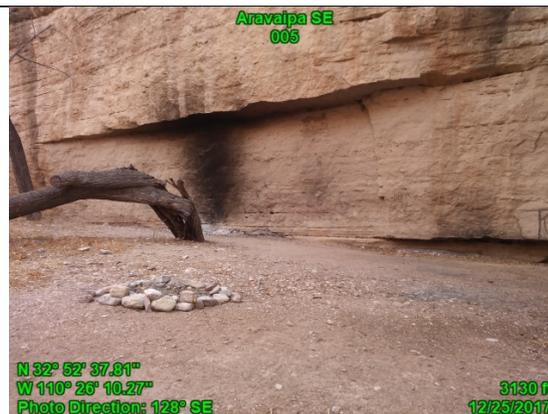
Unit name	Aravaipa SE
Point	005
Feature Class	Impact: Excluded
Feature	Campsite
Feature notes	Cumulative impacts
Route: Determination	N/A
Route: name	N/A
Route: Construction	N/A
Route: Use	N/A
Route: Maintenance	N/A
Route: Purpose	N/A
Route: Improvements	N/A
Other notes	Exclude this impact

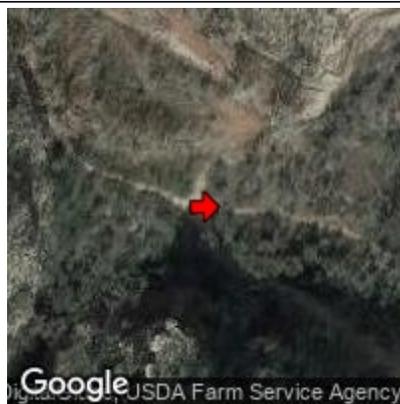
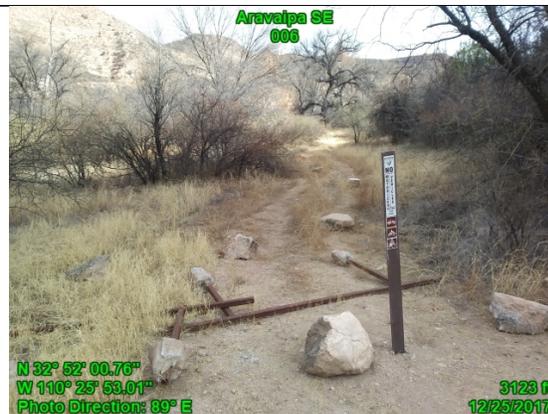
- 006 is a junction with a reclaimed and abandoned route, closed to vehicles by the BLM. 007 shows the revegetated condition of the route a short distance beyond the closure point. The old route forks to the southwest, leading to an abandoned, overgrown corral, and another BLM closure point (008). These impacts are substantially unnoticeable and minimally impact naturalness.

Unit name	Aravaipa SE
Point	006
Feature Class	Primitive Route
Feature	Closure point
Feature notes	Feature minimally affects naturalness
Route: Determination	Reclaimed & unused
Route: name	Not Named
Route: Construction	No evidence/user-created
Route: Use	No sign observed
Route: Maintenance	None
Route: Purpose	No apparent purpose
Route: Improvements	None
Other notes	None

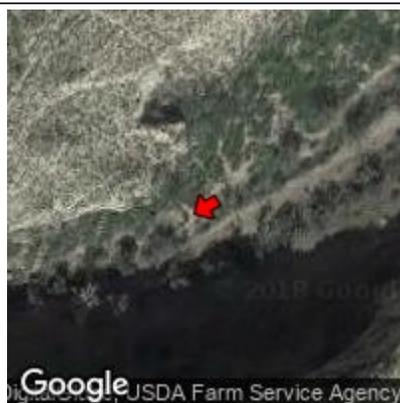
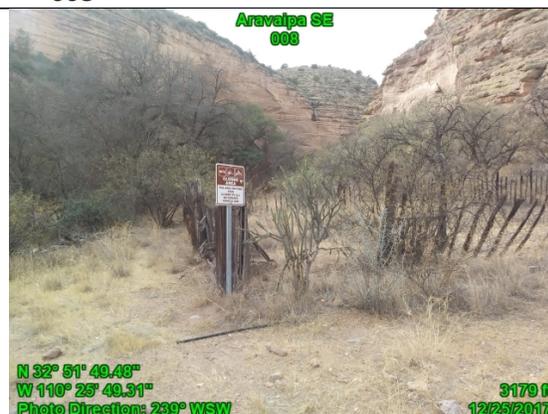
Unit name	Aravaipa SE
Point	008
Feature Class	Primitive Route
Feature	Closure point
Feature notes	Feature minimally affects naturalness
Route: Determination	Way
Route: name	Not Named
Route: Construction	No evidence/user-created
Route: Use	No sign observed
Route: Maintenance	None
Route: Purpose	No apparent purpose
Route: Improvements	None
Other notes	None

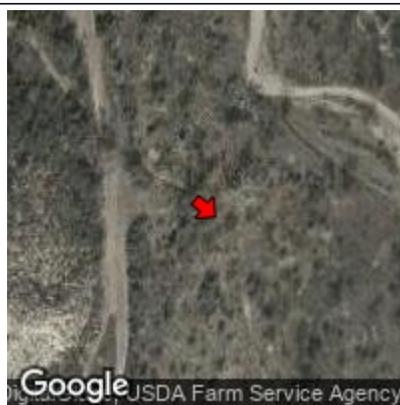
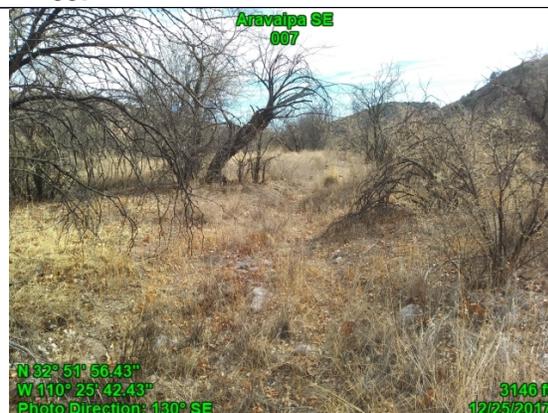
Unit name	Aravaipa SE
Point	007
Feature Class	Primitive Route
Feature	Revegetated/Naturalized
Feature notes	Feature minimally affects naturalness
Route: Determination	Reclaimed & unused
Route: name	Not Named
Route: Construction	No evidence/user-created
Route: Use	No sign observed
Route: Maintenance	None
Route: Purpose	No apparent purpose
Route: Improvements	None
Other notes	None

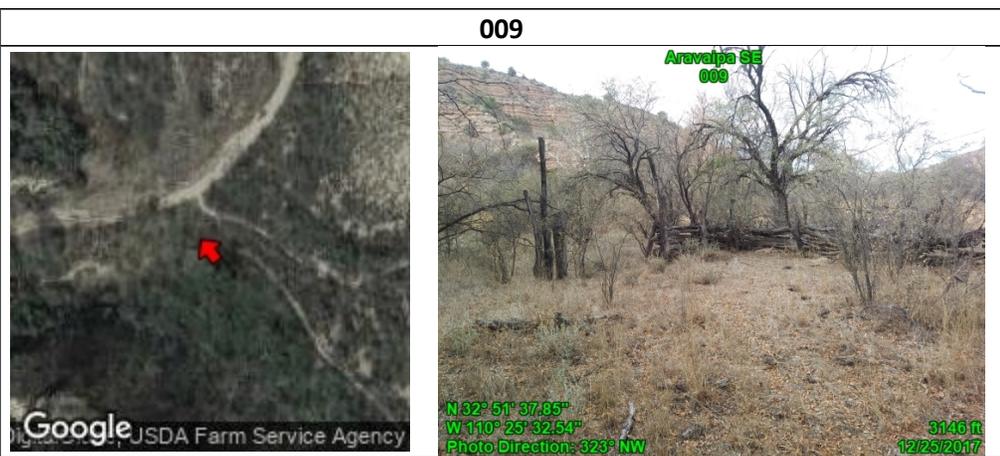
- 009 is another abandoned, overgrown corral along the old route to the southeast. Dense vegetation renders this impact substantially unnoticeable.
- At 010 the boundary road leaves turkey creek, climbing steeply and becoming very rough – impassable to most vehicles. Beyond this point the road is known as either BLM 5019 or the Rug Road. It is a dangerous route in very poor condition, but is occasionally used for recreation by offroaders.

Attributes	
Unit name	Aravaipa SE
Point	009
Feature Class	Impact: Acceptable
Feature	Corral
Feature notes	Equipment appears to be out of order and abandoned
Route: Determination	N/A
Route: name	N/A
Route: Construction	N/A
Route: Use	N/A
Route: Maintenance	N/A
Route: Purpose	N/A
Route: Improvements	N/A
Other notes	None

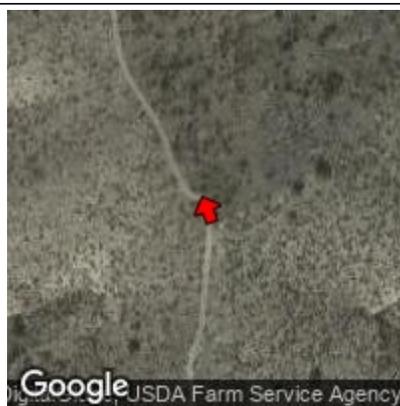
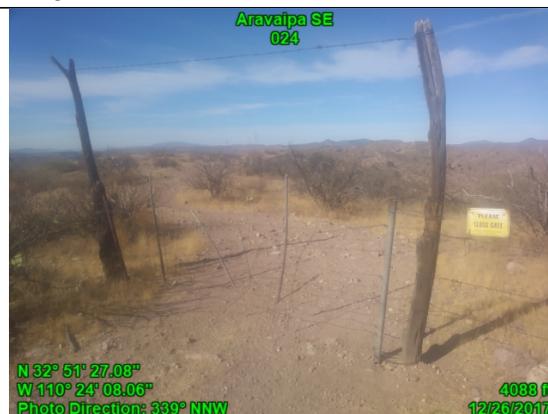
Unit name	Aravaipa SE
Point	024
Feature Class	Boundary Element
Feature	Sign
Feature notes	Used and maintained
Route: Determination	Road
Route: name	Not Named
Route: Construction	Bladed
Route: Use	4-WD Trucks
Route: Maintenance	Semi-recent evidence - 1-3 years ago
Route: Purpose	Multiple uses
Route: Improvements	Gate
Other notes	Unit Boundary

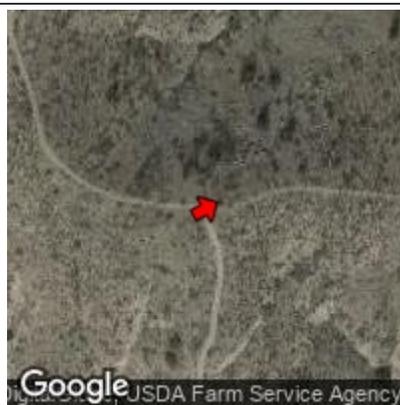
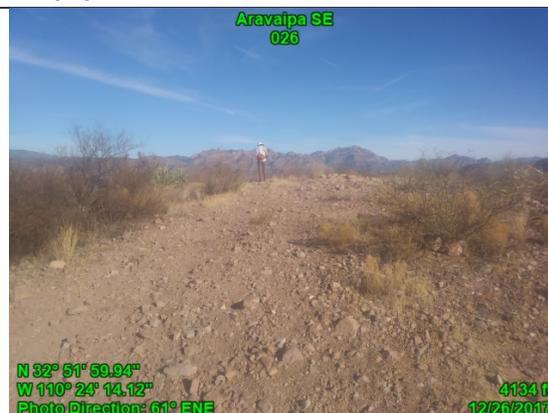
Unit name	Aravaipa SE
Point	026
Feature Class	Primitive Route
Feature	Junction of Routes
Feature notes	Feature minimally affects naturalness
Route: Determination	Way
Route: name	Not Named
Route: Construction	No evidence/user- created
Route: Use	4-WD Trucks
Route: Maintenance	None
Route: Purpose	No apparent purpose
Route: Improvements	None
Other notes	Kept open solely by passage of vehicles

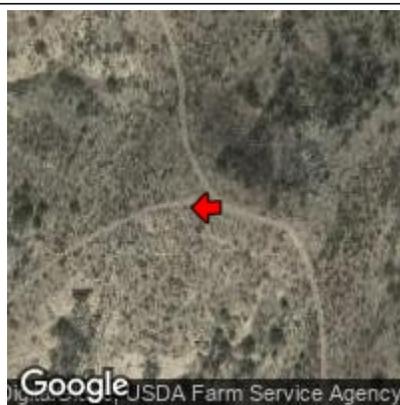
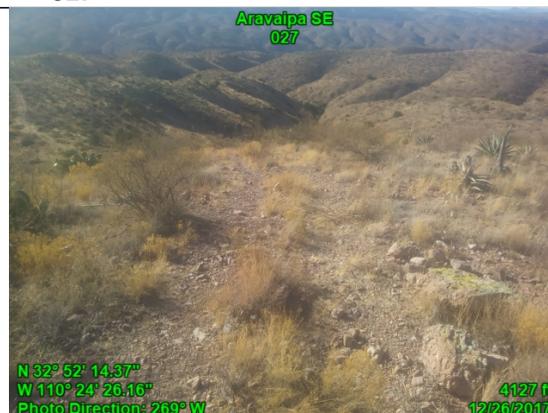
Unit name	Aravaipa SE
Point	027
Feature Class	Primitive Route
Feature	Low use/faint route
Feature notes	Feature minimally affects naturalness
Route: Determination	Way
Route: name	Not Named
Route: Construction	No evidence/user- created
Route: Use	4-WD Trucks
Route: Maintenance	None
Route: Purpose	No apparent purpose
Route: Improvements	None
Other notes	Kept open solely by passage of vehicles

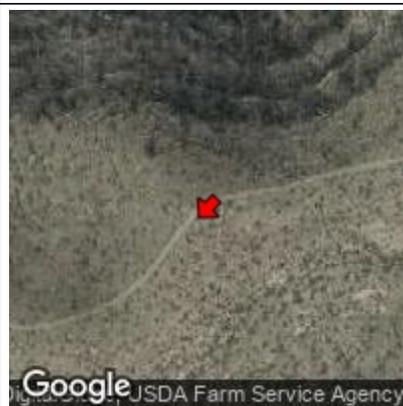
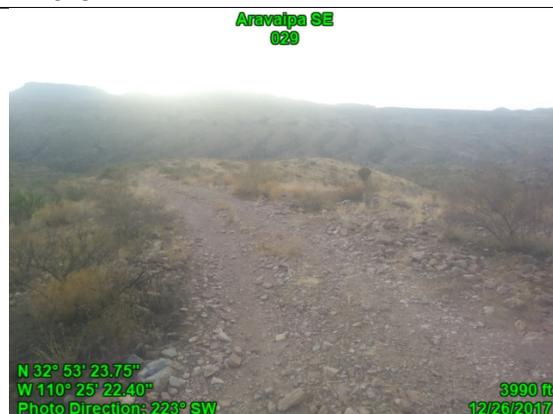
Unit name	Aravaipa SE
Point	029
Feature Class	Boundary Element
Feature	Campsite
Feature notes	Feature minimally affects naturalness
Route: Determination	Road
Route: name	Not Named
Route: Construction	Bladed
Route: Use	4-WD Trucks
Route: Maintenance	None
Route: Purpose	Camping
Route: Improvements	None
Other notes	Cherrystem

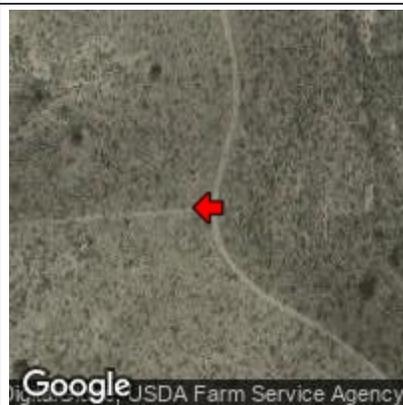
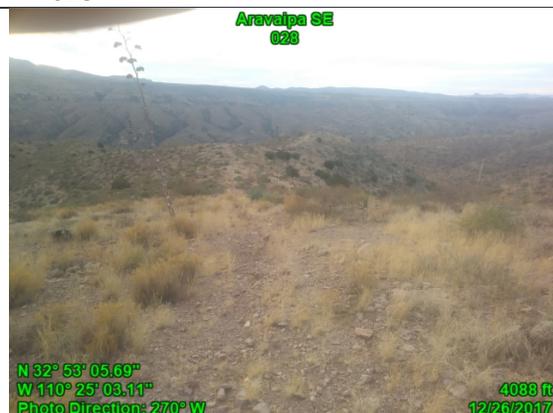
Unit name	Aravaipa SE
Point	028
Feature Class	Primitive Route
Feature	Low use/faint route
Feature notes	Feature minimally affects naturalness
Route: Determination	Reclaimed & unused
Route: name	Not Named
Route: Construction	No evidence/user-created
Route: Use	No sign observed
Route: Maintenance	None
Route: Purpose	No apparent purpose
Route: Improvements	None
Other notes	None

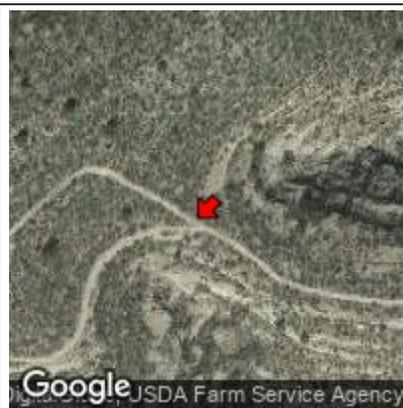
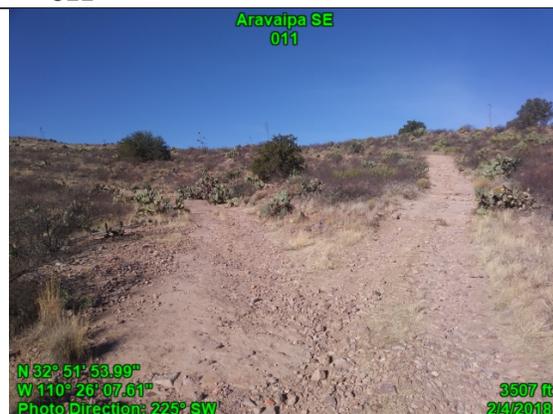
Unit name	Aravaipa SE
Point	011
Feature Class	Boundary Element
Feature	Junction of Routes
Feature notes	Boundary follows 5019 b to left
Route: Determination	Road
Route: name	BLM Route 5019b
Route: Construction	Bladed
Route: Use	Misc. Off Road Vehicles
Route: Maintenance	None
Route: Purpose	Recreation
Route: Improvements	None
Other notes	Unit Boundary

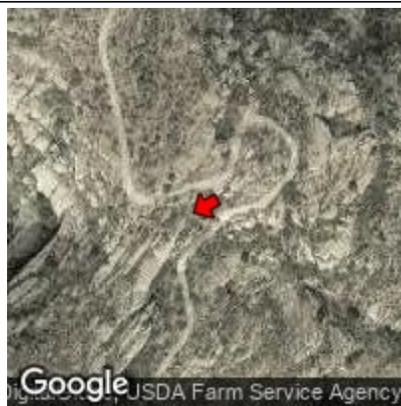
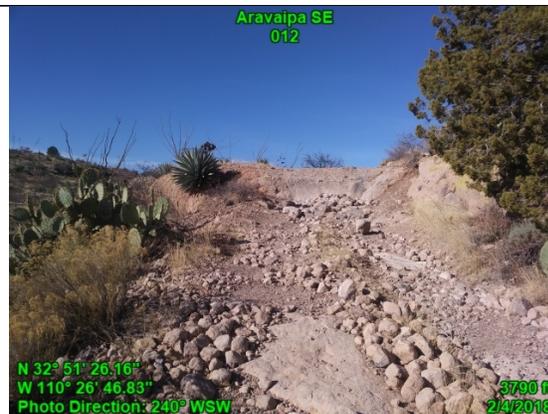
- 012 shows a major vehicle obstacle presented by a 3-4 foot drop. These heavily eroded and dangerous conditions are typical of the route.
- 013 is a junction with a faint, unmaintained way to the east. 014 shows typical condition of the route, which shows recent signs of use only by horses.

Unit name	Aravaipa SE
Point	012
Feature Class	Primitive Route
Feature	Typical Condition of Route
Feature notes	Feature minimally affects naturalness
Route: Determination	Road
Route: name	BLM Route 5019
Route: Construction	Bladed
Route: Use	Misc. Off Road Vehicles
Route: Maintenance	None
Route: Purpose	Recreation
Route: Improvements	None
Other notes	Unit Boundary

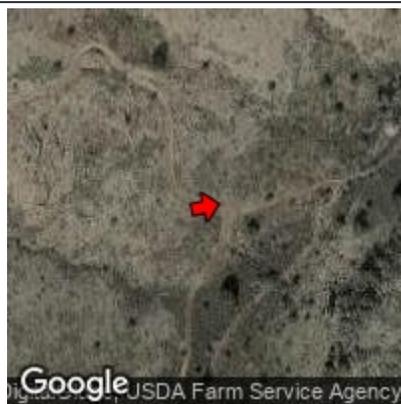
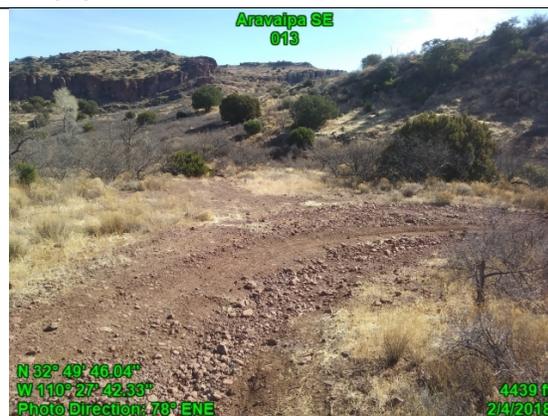
Unit name	Aravaipa SE
Point	013
Feature Class	Primitive Route
Feature	Junction of Routes
Feature notes	Feature minimally affects naturalness
Route: Determination	Way
Route: name	Not Named
Route: Construction	No evidence/user-created
Route: Use	Equestrian
Route: Maintenance	None
Route: Purpose	No apparent purpose
Route: Improvements	None
Other notes	None

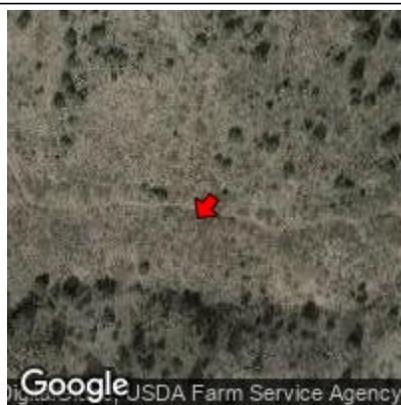
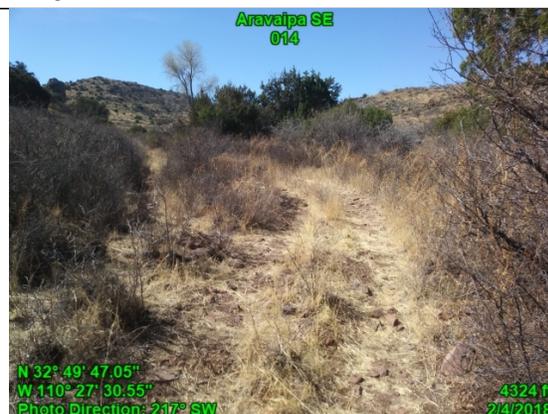
Unit name	Aravaipa SE
Point	014
Feature Class	Primitive Route
Feature	Typical Condition of Route
Feature notes	Feature minimally affects naturalness
Route: Determination	Way
Route: name	Not Named
Route: Construction	No evidence/user-created
Route: Use	Equestrian
Route: Maintenance	None
Route: Purpose	No apparent purpose
Route: Improvements	None
Other notes	Horsepack route

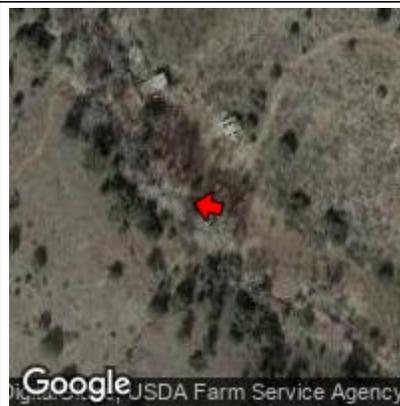
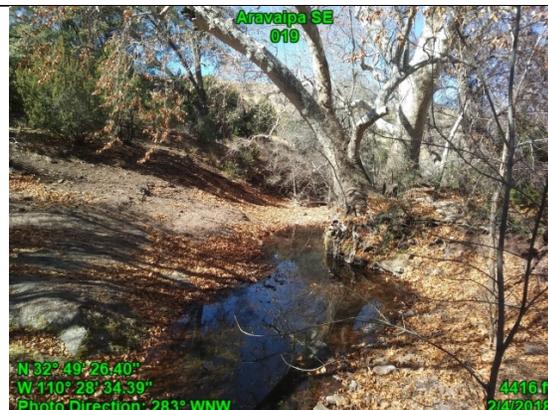
Unit name	Aravaipa SE
Point	019
Feature Class	Impact: Acceptable
Feature	Spring at parsons grove
Feature notes	Equipment appears to be out of order and abandoned
Route: Determination	N/A
Route: name	N/A
Route: Construction	N/A
Route: Use	N/A
Route: Maintenance	N/A
Route: Purpose	N/A
Route: Improvements	None
Other notes	Majestic sycamores

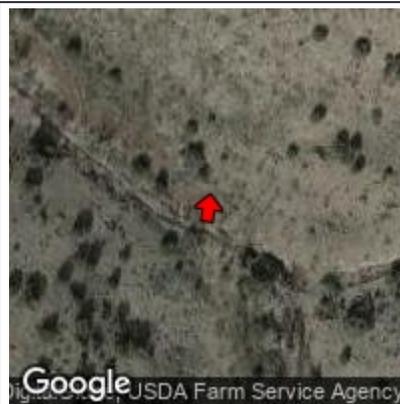
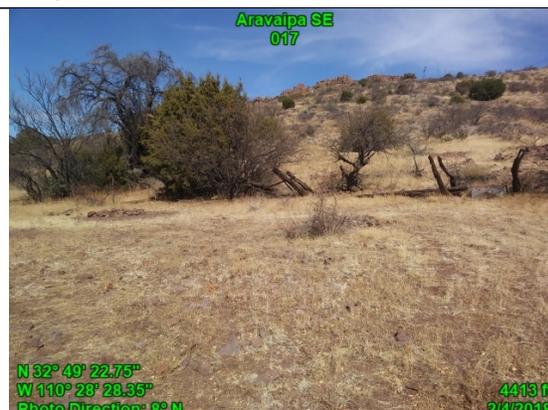
Unit name	Aravaipa SE
Point	017
Feature Class	Primitive Route
Feature	Campsite
Feature notes	Equipment appears to be out of order and abandoned
Route: Determination	N/A
Route: name	N/A
Route: Construction	N/A
Route: Use	N/A
Route: Maintenance	N/A
Route: Purpose	N/A
Route: Improvements	None
Other notes	None

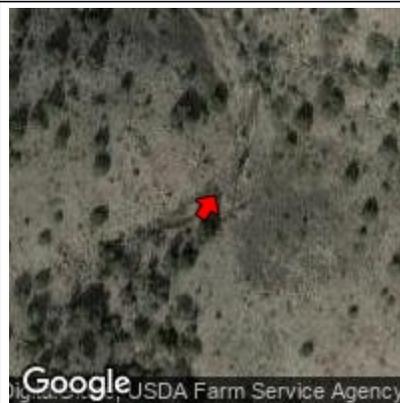
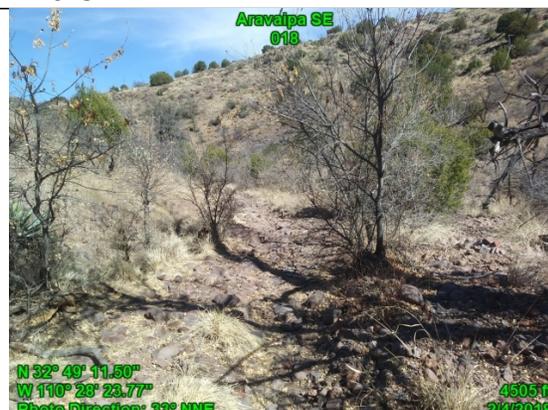
Unit name	Aravaipa SE
Point	018
Feature Class	Primitive Route
Feature	Low use/faint route
Feature notes	Pack trail
Route: Determination	Way
Route: name	Not Named
Route: Construction	No evidence/user-created
Route: Use	Equestrian
Route: Maintenance	None
Route: Purpose	Recreation
Route: Improvements	None
Other notes	No signs of vehicle use

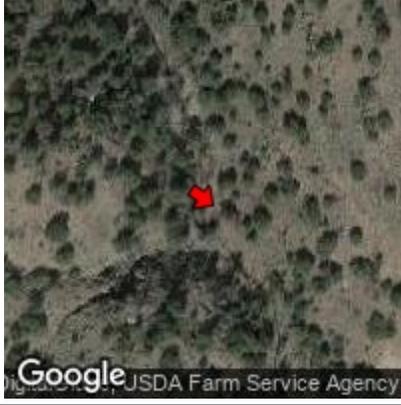
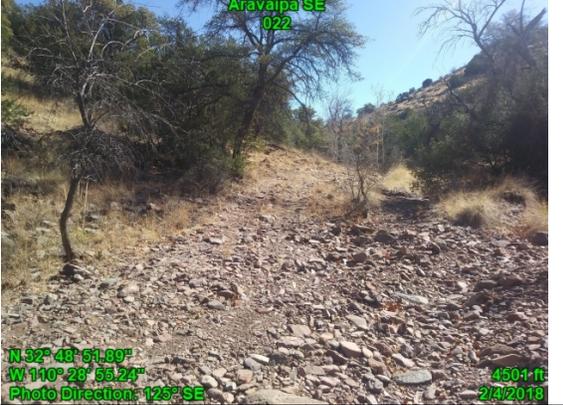
Attributes	
Unit name	Aravaipa SE
Point	022
Feature Class	Primitive Route
Feature	Low use/faint route
Feature notes	Feature minimally affects naturalness
Route: Determination	Way
Route: name	N/A
Route: Construction	No evidence/user-created
Route: Use	Misc. Off Road Vehicles
Route: Maintenance	None
Route: Purpose	Recreation
Route: Improvements	None
Other notes	Kept open solely by passage of vehicles
