Black Mountain Wilderness Proposal

**ARIZONA
WILDERNESS
COALITION**

October 2004

Route Analysis and Photo Documentation
For the
Black Mountain Unit

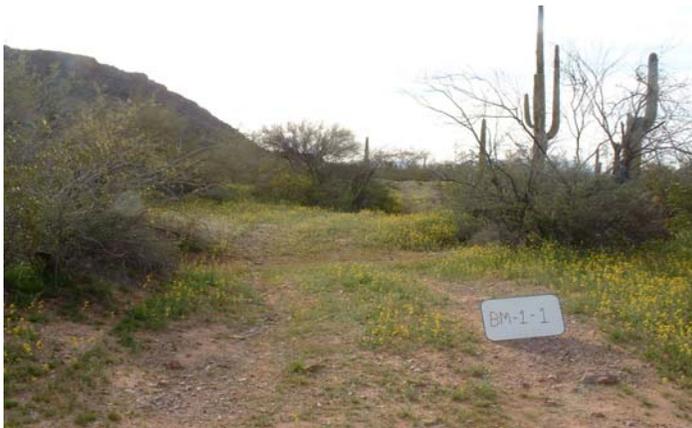
BM-1-1 Average conditions on route 1

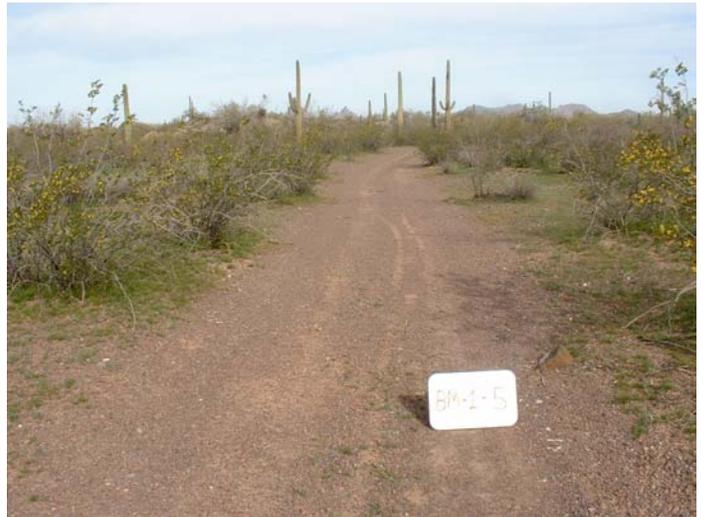
BM-1-5 Average conditions on 1

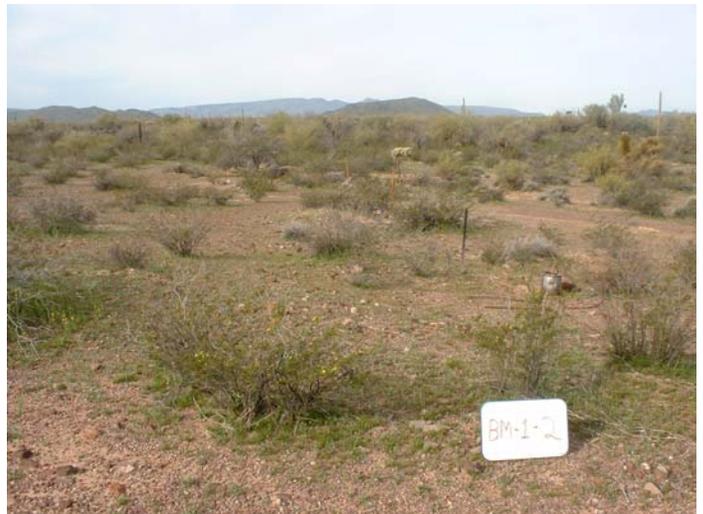
BM-1-2 Prospect, well, and claim posts on route 1

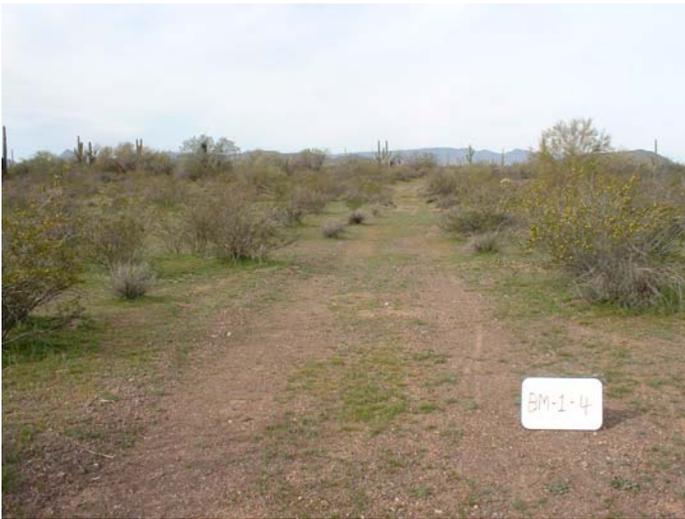
BM-1-4 Junction route 1 and 2
Direction: SW

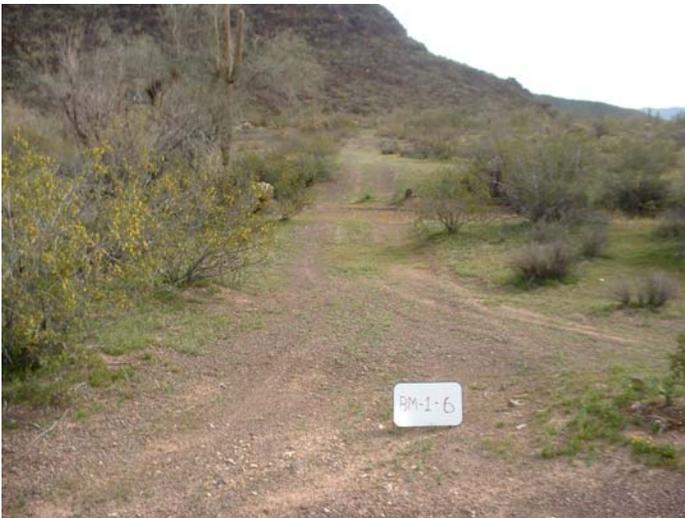
BM-1-6 Junction route 1 and 5
Direction: NE

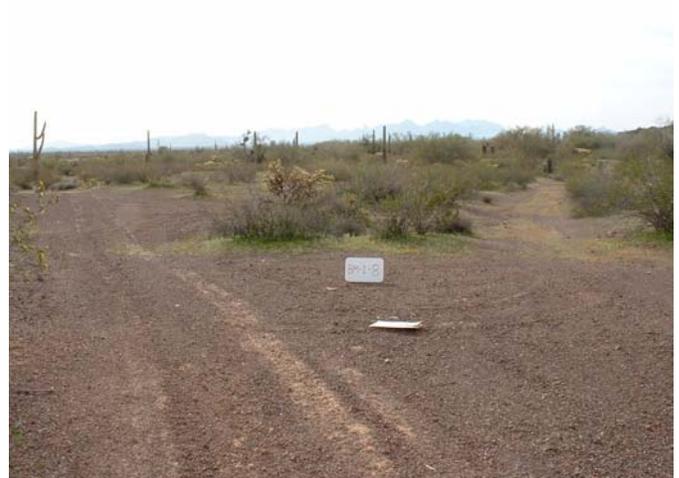
BM-1-8 Junction with routes 1 and 3
Direction: SE

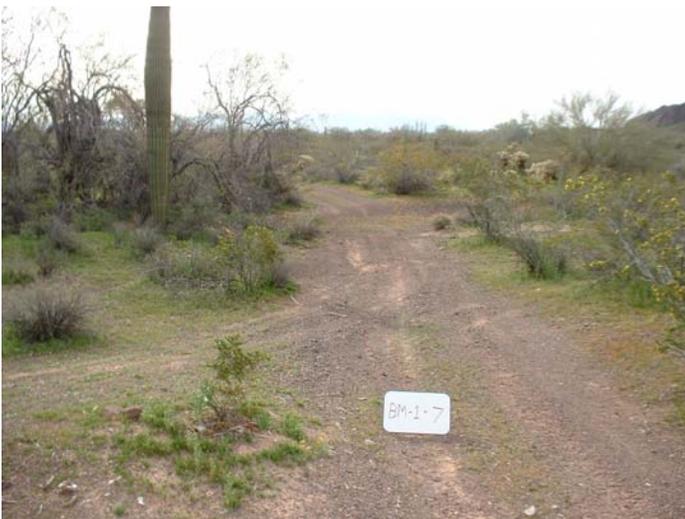
BM-1-7 Average conditions on route 1
Direction: SE

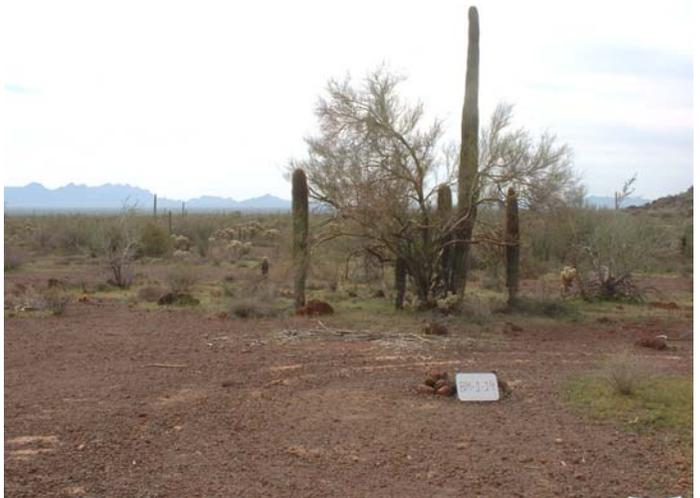
BM-1-14 end 4 used fire ring
Direction: S

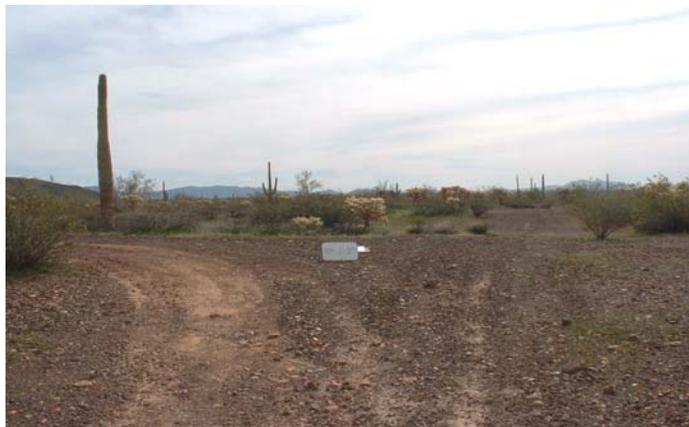
BM-1-10 Junction with routes 3 and 4
Direction: E

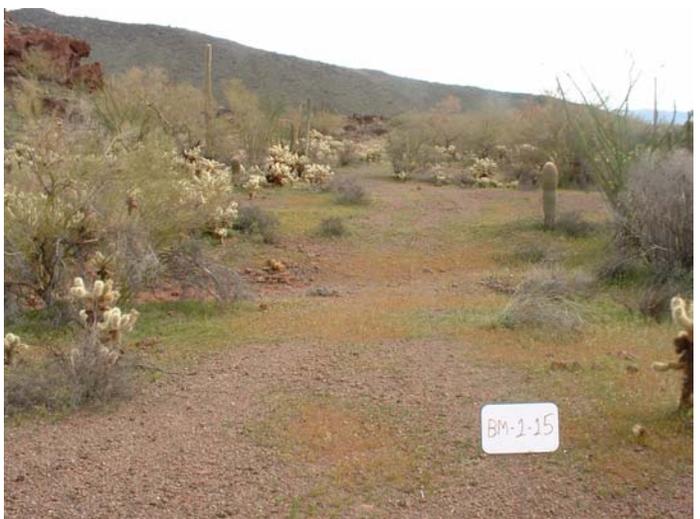
BM-1-15 Old route no use evident
Direction: E

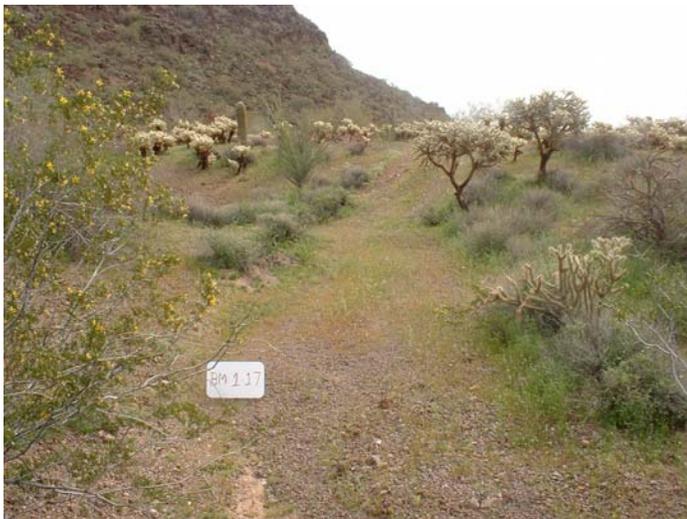
Notes: This is an old prospect route that is reclaimed and has no seen any recent use. It fades out even more past the point where it is marked on the map. It should be closed to protect wilderness characteristics.

BM-1-17 Route 5 overgrown no use evident

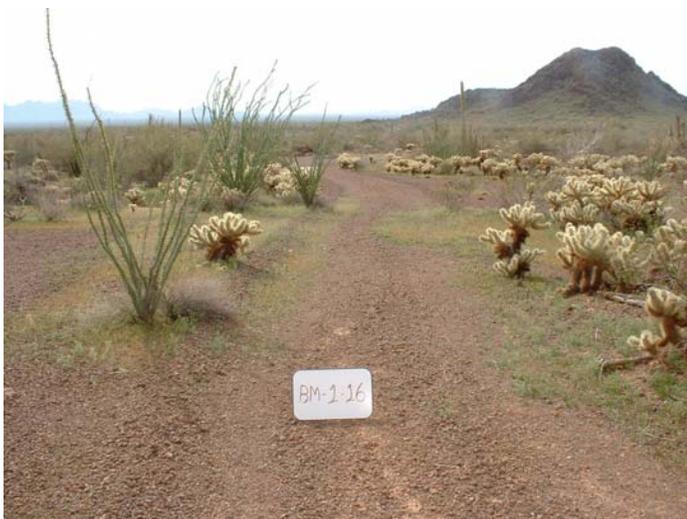
BM-1-16 Average conditions on route 5 mining claim posts Direction: S

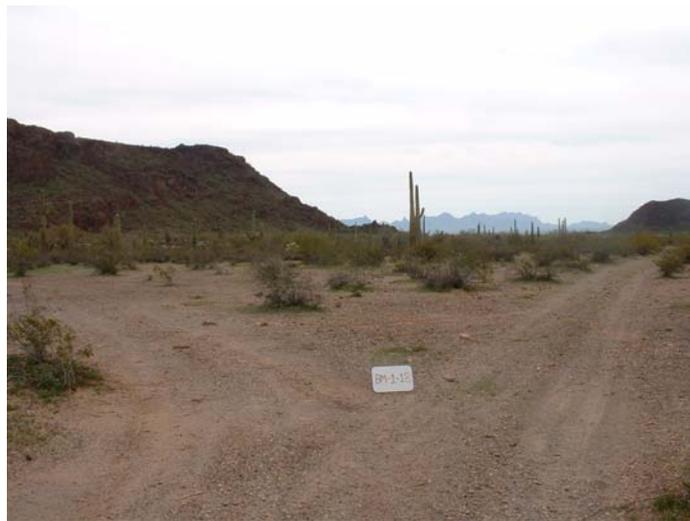
BM-1-18 Junction routes 1 and 6

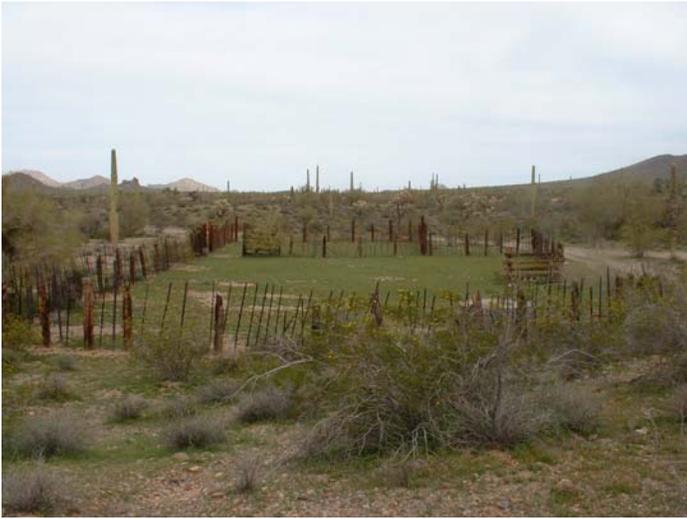
BM-1-19 Corral
Direction: N

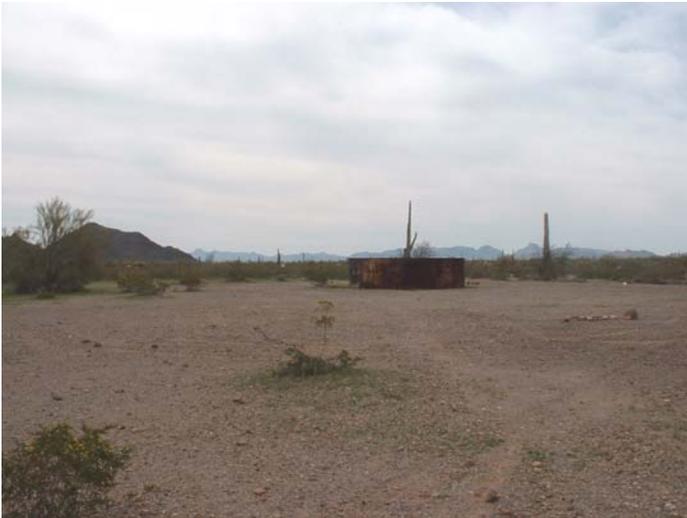
BM-1-20 Water tank
Direction: S

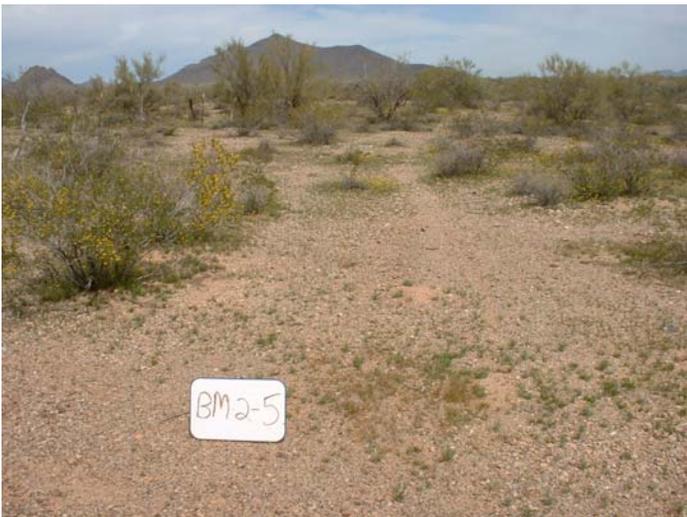
BM-2-5 Reclaimed route off of route 7
Direction: NW

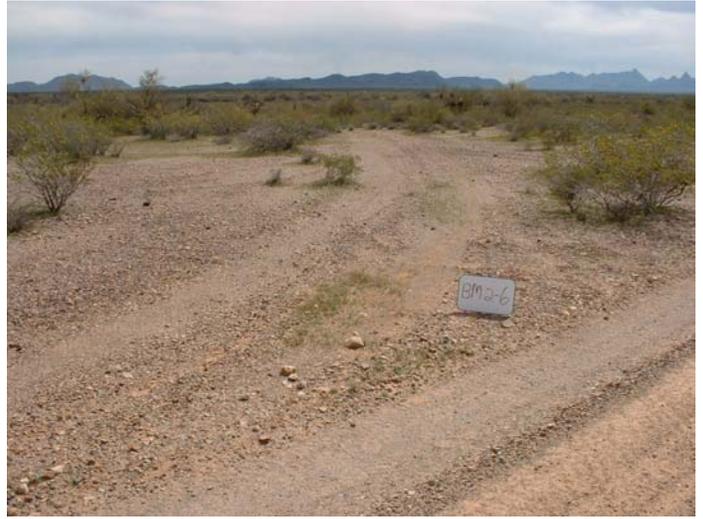
BM-2-6 Old shortcut route on route 7
Direction: E

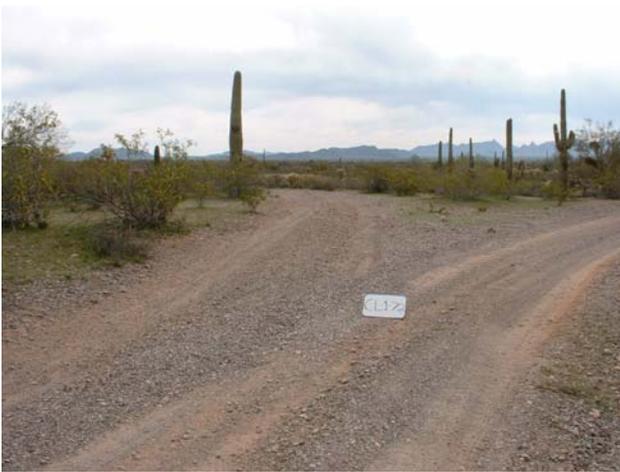
CL-1-72 Junction routes 7 and 8
Direction: S

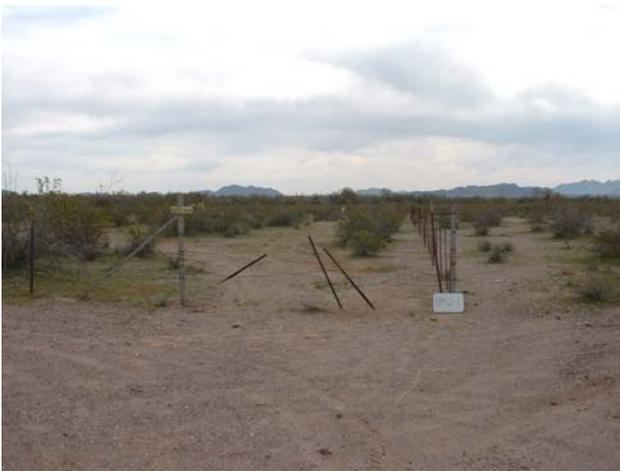
BM-2-1 End route 7 at guzzler
Direction: E

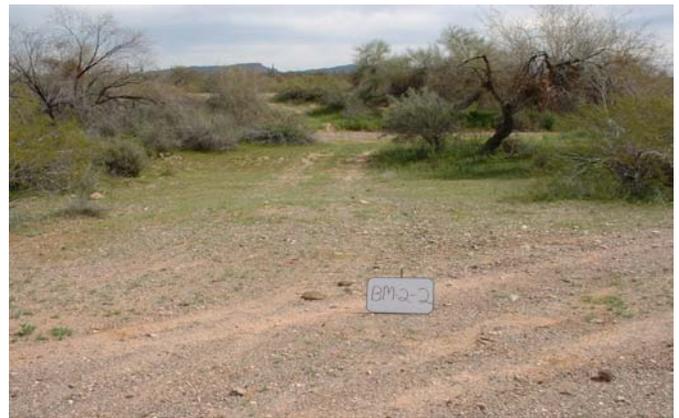
Notes: this route was created by users pushing further on the end of route 8. Only one small campsite exists near wash. Many better campsites exist on other side of road further away from the guzzler, as users must camp at least ¼ mile away from it. Closure would also allow more wildlife to take advantage of the wash corridor to access the guzzler.

BM-2-2 Short route into wash on route 9 stops on other side. Direction: E

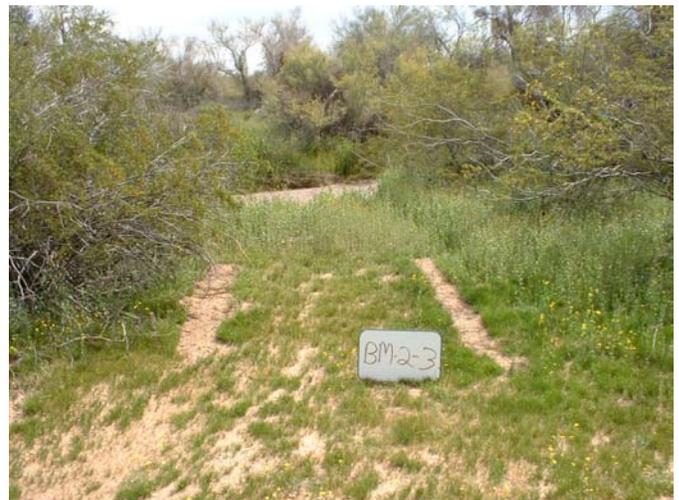
BM-2-3 End route 9
Direction: E

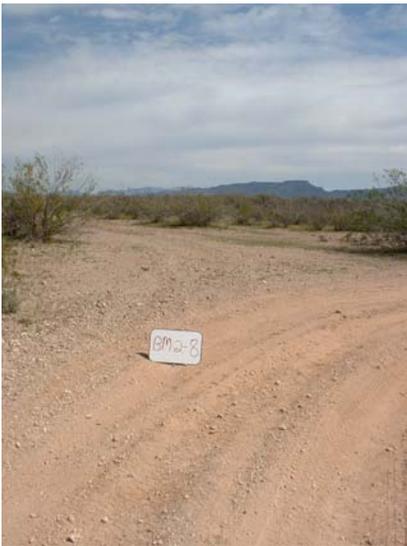
BM-2-8 Junction routes 7 and 10
Direction: NE

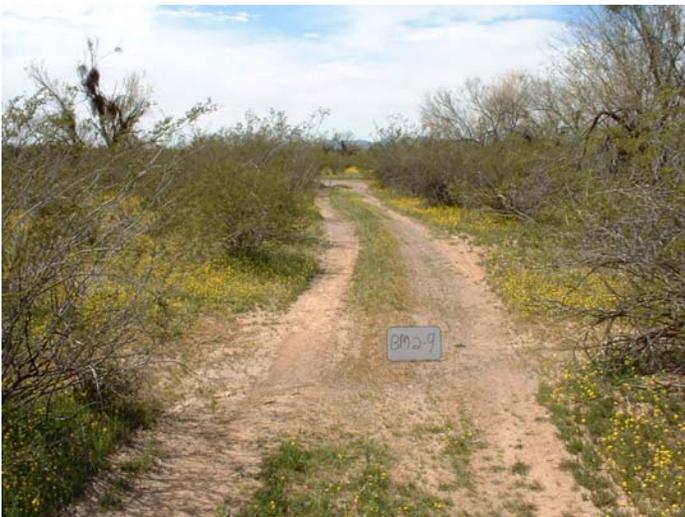
Notes: This route is redundant with route 11. Both are in very poor condition. High Clearance 4 wheel drive is absolutely necessary. No matter how this route was created it should be closed since route #11 is on the quadrangle for the area and will be easier for users to understand.

BM-2-9 Average conditions on route 10
Direction: S

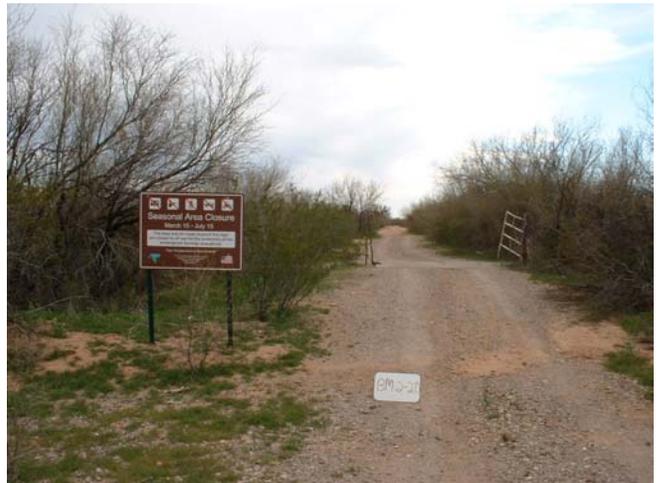
BM-2-20 Beginning route 12
Direction: S

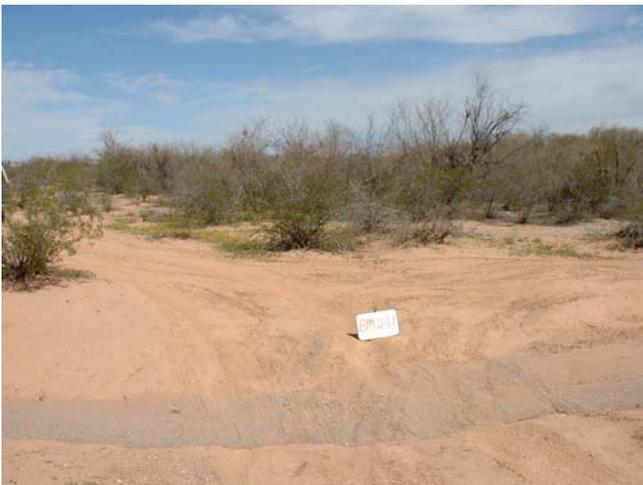
BM-2-11 Junction routes 12 and 10
Direction: NE

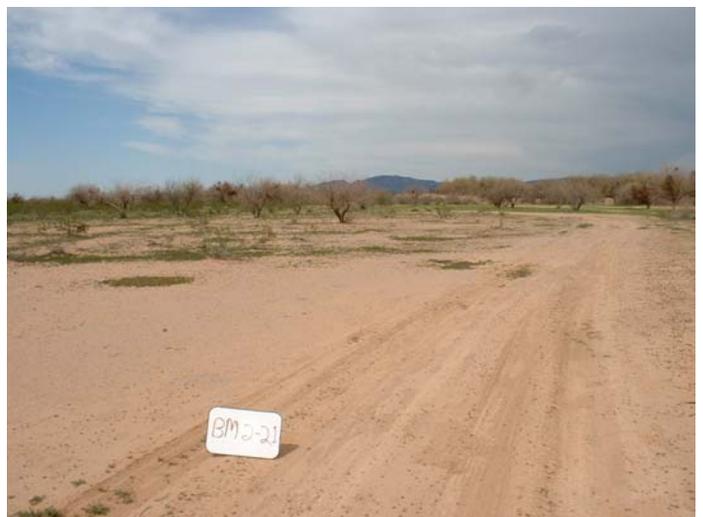
BM-2-21 Average conditions of first mile of route 12
Direction: NE

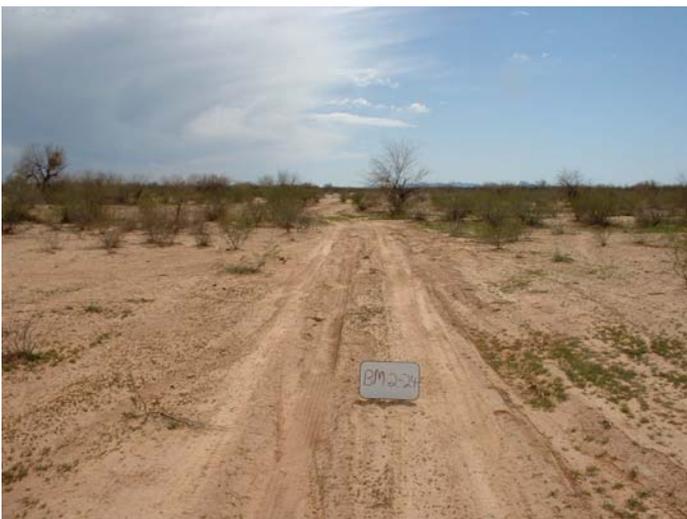
BM-2-24 Average conditions on route 12 Direction: S

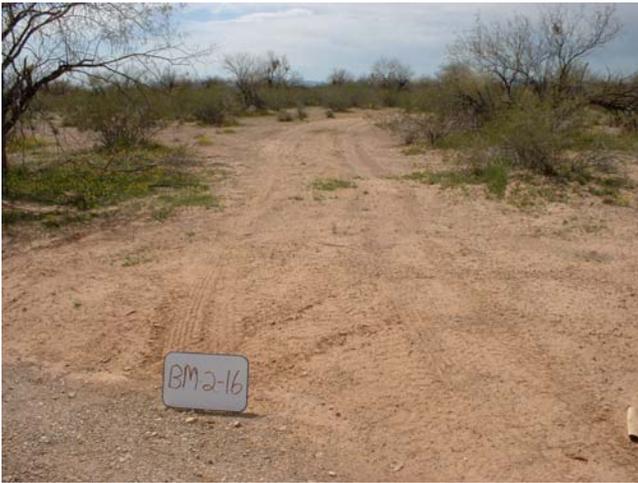
BM-2-16 Junction routes 12 and 14
Direction: S

Notes: This route was probably created to maintain the fence line that it runs along. There is a parallel route on the other side of the fence for some of the length. This route has not seen much use by the rancher recently, but ORVs have found it and made some donuts on sensitive desert pavement. I followed it until it looked like no use was evident at photo BM-2-17. It probably continues following the fence. It is unlikely that this route is necessary for maintenance of the fence line and should be closed.

Proposed Action: close

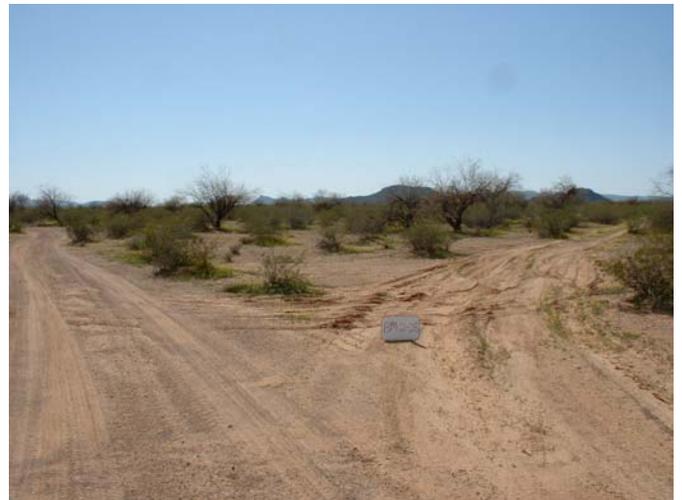
BM-2-28 Junction routes 12 and 15
Direction: W

Notes: This route is a recently user created wildcat route. Users may have wanted access to the more remote rugged country of Black Mountain. This route is a perfect example of what users will do with out being restricted to created and maintained routes. This route has probably seen between 5 and 10 uses and must be closed. Its closure will protect the outstanding wilderness characteristics that are present at its end.

Proposed Action: close

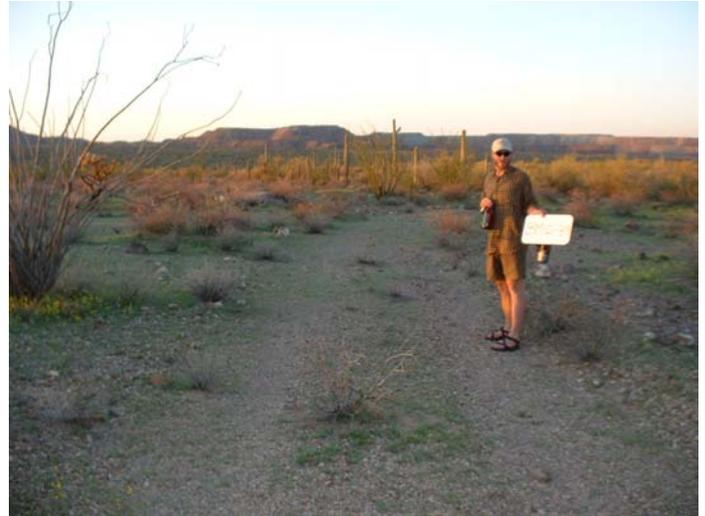
BM-2-39 No use evident on route 16
Direction: N

Route #: 16
Photos: BM-2-39
Length: .40 miles
Construction Type: bladed at one time long ago
FLPMA Road Definition: no
Campsites: 0
Vehicle Type: N/A
Erosion: stable
Vegetation Present: bare soil is between 25-50% of surface some grasses
Other Impacts:
Proposed Action: reclaimed/close
Notes: This route was created for mining prospects in the area and has not seen use in a number of years. It is almost fully reclaimed. It should be removed from the quadrangles to prevent user confusion.

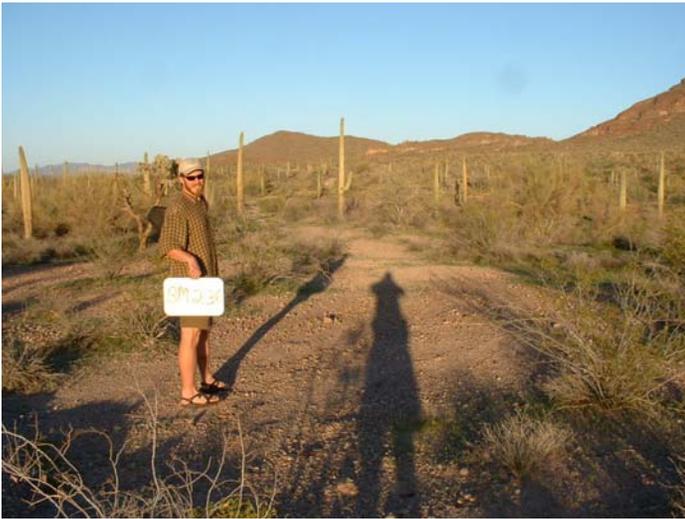
BM-2-36 Junction routes 18 and 17
Direction: E

Route #: 17
Photos: BM-2-36; BM-2-37; BM-2-38; BM-2-40
Length: .64 miles
Construction Type: bladed long ago
FLPMA Road Definition: no
Campsites: 0
Vehicle Type: HC 4WD
Erosion: 18-24 inches of soil lose
Vegetation Present: bare soil is between 25-50% of surface some desert pavement and grasses
Other Impacts:
Proposed Action: reclaimed/close
Notes: This route was created for mining prospects in the area and has seen one use in the recent past. It is mostly reclaimed. It should be closed and removed from the quadrangles to prevent user confusion. It may make a nice hiking trail.

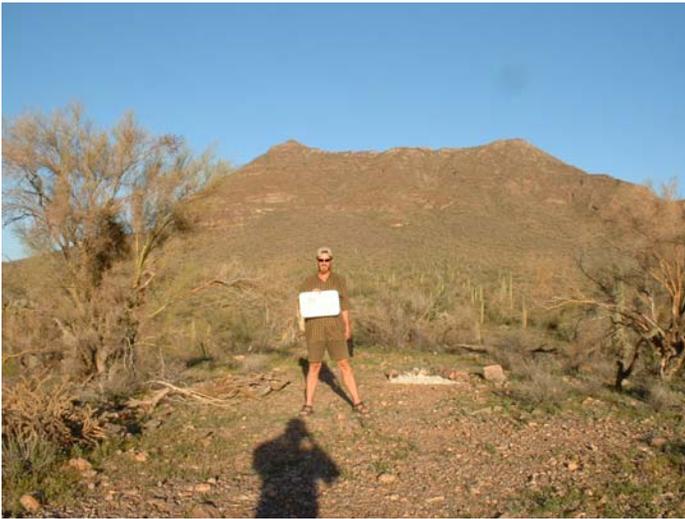
BM-2-35 Campsite along route 18
Direction: SE

Notes: This road is called Darby Well Road and hooks up with Bates Well Road. It forms the entire Western boundary for the Black Mountain Wilderness Study Area Unit. It provides excellent opportunities for sightseeing and camping.

Proposed Action: open
